Doctoral Thesis

**Structural Condition Assessment of Existing
Steel Bridges Based on Non-destructive
Evaluation.**

Gifu University

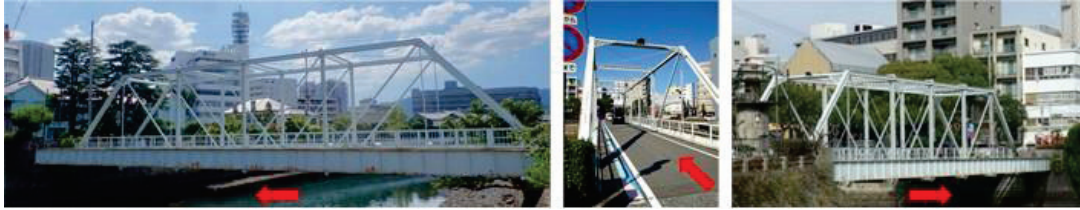
Figure 2.3. Dejima Bridge – Nagasaki 1890 (Sanchez & Ney, N.d).

Most of the steel bridges are old but still in operation, though to some extent degraded. For instance, Dejima Bridge Nagasaki, that was constructed in 1890 (132 years ago) shown in Figure 2.3 [16]. Rapid replacement of the same would subject the responsible authority to unwanted financial predicaments. Thus, preventive maintenance approach [17] is held in high regard over corrective maintenance approach to curb on the cost and vulnerability due to failure. Though, best practices call for the combination of the two for optimization. However, the old structures' design and specification documents are mostly not readily available or even completely absent in the authority in charge i.e., municipal offices that account for 80% of the total road assets [5]. Furthermore, as of 2021 more than 31% - approximately 230,000 structures lacked historical information in

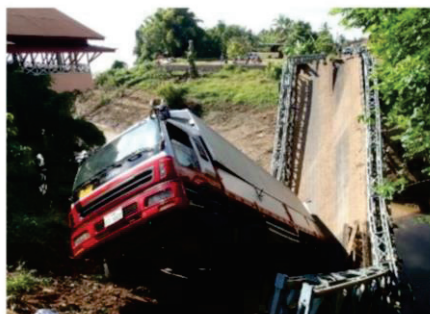
Figure 2.9. Bailey bridge collapse due to deterioration (Chowdhury, N.d.)

In response to the damage because of natural phenomena such as earthquakes and floods in the recent years within Japan, there is need to develop a restoration/adaptation framework of temporary/semi-permanent steel bridges. Numerous approaches have been advanced [50] bringing to focus steel bailey bridges. However, within the nation the developments of adaptation frameworks are limited. Temporary bridges are characterised by lack of maintenance and missing historical records i.e., as built drawings and maintenance reports. Therefore, the need to come up with an appropriate maintenance- and adaptation approach to avoid their rapid deterioration and eventual collapse or eminent failure as illustrated in Figure 2.9 is essential [51] hence increase their service life.

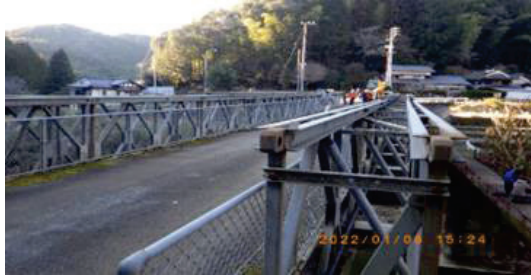
Figure 3.2. Sukumo bridge - Target Bailey Bridge

Figure 3.2 shows the target bailey bridge referred to as the Sukumo bailey bridge. The bridge is in Uchiko Town, Kita District, Ehime Prefecture, along the junction of Route 56 highway. The bridge was built in 1997 as a temporary structure to serve as an access for constructing one of the Matsuyama Expressway (E56) piers across the Nakayama River. Additionally, after the completion of the main line it was meant to serve as a town road courtesy of Japan Highway Public Corporation. The bridge spans 31.81 m, having a carriage width of 4.0 m, as shown in Figures 3.2a, 3.2b, and 3.2c. The bridge has an alleged loading capacity of 25 T, sourced from interviews from Uchiko Town municipal offices. It is a third-generation bailey bridge Acrow type Double Single Reinforced (DSR), with a panel of 3.976 and 2.134 m, length, and height, respectively.

(a) Sukumo bridge

An FEA was done to validate the bridge's static structural behavior. Figure 3.10 shows the numerical structural model. It was modeled according to in situ geometrical dimensions, as shown in Figure 3.2b, c. However, the detailed design and specifications were not available. By design, modeling should adhere to reliable documentation (as-built drawings) related to its geometry and material. The geometric structural details were recorded from the site. Instances where structural details are still unclear even after on-site measurement, the Japanese, Philippine [84], Garden Reach Shipbuilders and Engineers Limited (GRSE) [85], and Eurocode 1 & 2 [86,87] supplemented each other for any unclear details i.e., geometric properties. Consequently, the geometrical properties were considered with on-site dimensions provided in Table 2. A beam element with 6 degrees of freedom at the respective nodes was applied to the superstructure, employing a 1-Dimensional element family convention i.e., B32 (Beam, beam in a 3D space and quadratic). The beam element is mainly used for checking structural support systems. Quality is far more critical than complexity, as is commonly used in structural design [88]. As a result, increasing the computational speed beam element sufficed for the task. Some members were idealized; pin connections were modeled monolithically between the panel members [18]. The deck section was modeled as a shell element [88].

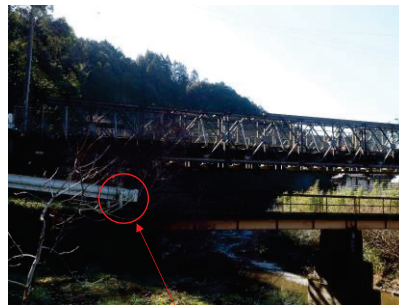
(b) Determination of a deflection based on the relationship of the target and fixed guard rail bolt - Plane view.
