DOCTORAL DISSERTATION

**STRUCTURAL DETAILS OF
TEXTILE REINFORCED
CONCRETE**

Mechanical and Civil Engineering Division
Graduate School of Engineering, Gifu University

BUI SI MUOI

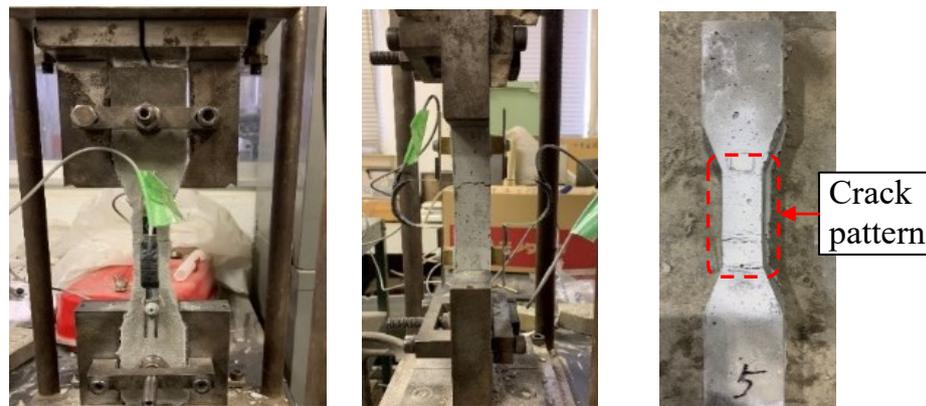
Figure 2.6 – Test setup and crack pattern of SHCC specimen

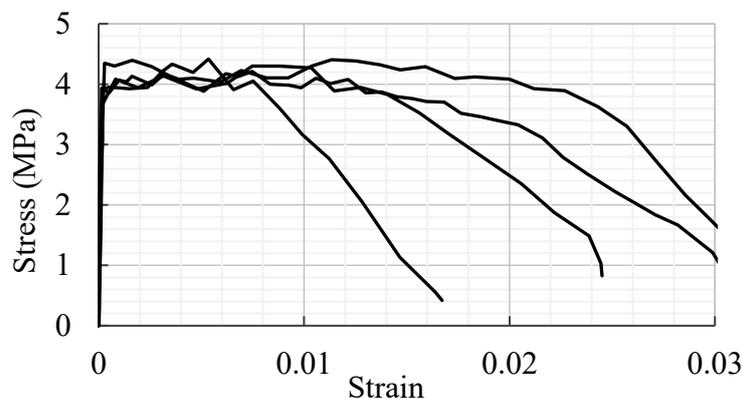
Figure 2.7 – Stress-strain relationship of SHCC

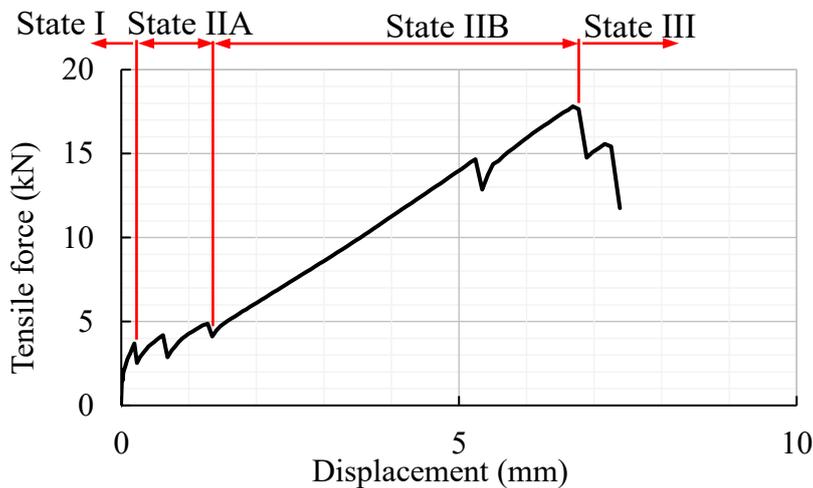
Figure 2.10 demonstrates the tensile force-displacement relationship. There are four states for TRC: State I (uncracked concrete), State IIA (crack formation), State IIB (crack stabilization), and State III (failure state). State I corresponds to the

elastic state of the uncracked TRC member, where the stiffness is entirely a function of the concrete matrix. First cracking takes place once the tensile strength of concrete is reached, which following initiates the tensile stresses in the textile reinforcement within the cracked region. Multiple crack formation follows with a minimal increase in load, defined as State IIA. The crack formation eventually stabilizes in State IIB. Lastly, the failure of TRC occurs when the delamination between textile and mortar occurred and expanded (see Figure 2.11). The tensile stress of the yarns at the point of failure load could be determined by dividing failure load by numbers of yarn and cross-section area of individual yarn. The average tensile stress of the yarns was 1550 N/mm², came close to reaching their tensile strength (1700 N/mm²). It indicates a good and promising combination between examined mortar and the textile.

Figure 2.10 – Typical tensile force-displacement relationship of TRC specimens made of high strength ordinary mortar

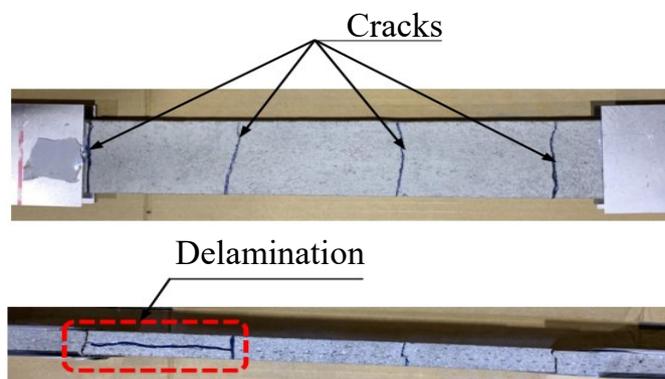
Figure 2.11 – Crack pattern of TRC member

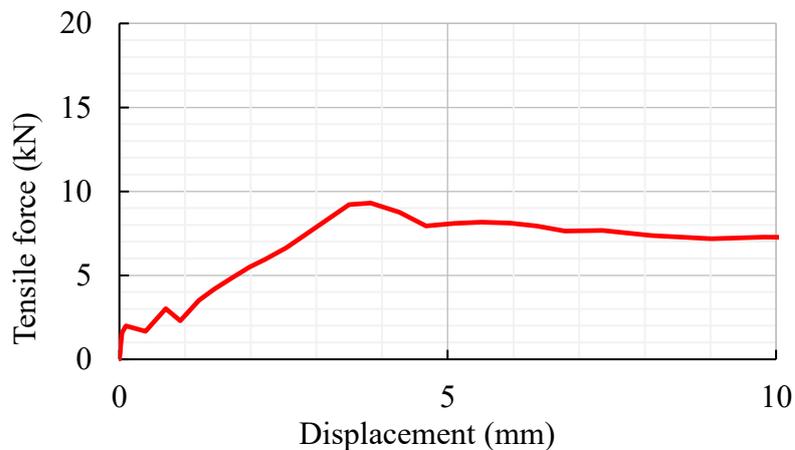
As shown in Figures 2.12 and 2.13, the pre-peak regime of specimens made of low and high strength ordinary mortar is quite similar. After initial matrix cracking, increases in the tensile load result in the formation of new cracks, and their spacing is dependent on the stress transfer between textile and matrix as quantified by the pull-out behavior and bond strength. The multiple-cracking stage terminates when all the additional loading is carried by the reinforcement and no further cracks occur in the matrix. Based on crack patterns, it can see that the high strength ordinary mortar exhibits better bond strength and stress transfer than low strength ordinary mortar as combined with the textile. Besides, the average peak load in the case of low strength ordinary mortar is 9.2 kN, much lower than the load-bearing capacity of high strength ordinary mortar cases. In terms of failure mode, specimens made of low strength ordinary mortar failed by debonding between textile and matrix, whereas delamination occurred in the case of specimens made of high strength ordinary mortar.

Figure 2.12 – Typical tensile force-displacement relationship of TRC-LS specimens made of low strength ordinary mortar

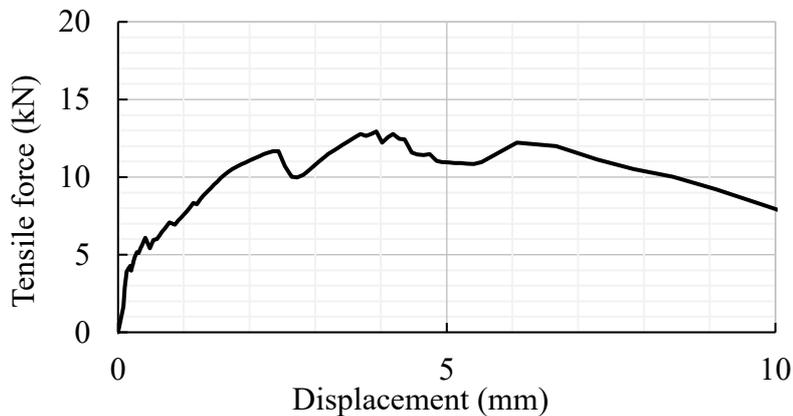
Figure 2.14 illustrated the typical tensile force-displacement relationship of TR-SHCC specimens. Generally, this relationship could be divided into four states, which was similar to the behavior of TRC and TRC-LS specimens. However, there were minor differences in the number of cracks and crack width of TR-SHCC specimens. As illustrated in Figure 2.15, a great number of cracks, particularly fine cracks, were observed in state IIA. The difference may come from the strain hardening behavior, in particular the crack bridging characteristics of SHCC. Besides, the peak load of the TR-SHCC specimen was 13.1 kN that was much lower than that of the high strength ordinary mortar case. The reason may be the weak bonding between textile and SHCC, which led to the low composite of TR-SHCC specimens (see section 3.3.2). However, in the post-peak stage, TR-SHCC specimens were able to sustain the high level of loading as deformation increased, indicating that TR-SHCC exhibited better behavior of ductility and robustness in comparison with specimens made of high strength ordinary mortar. Compared with TRC-LS specimens, TR-SHCC specimens provide a quite higher load-bearing capacity. The reason for this might be the influence of weak bond strength between the textile and low strength ordinary mortar, which leads to a premature bonding failure in TRC-LS specimens.

Figure 2.14 – Typical tensile force-displacement relationship of TR-SHCC specimens

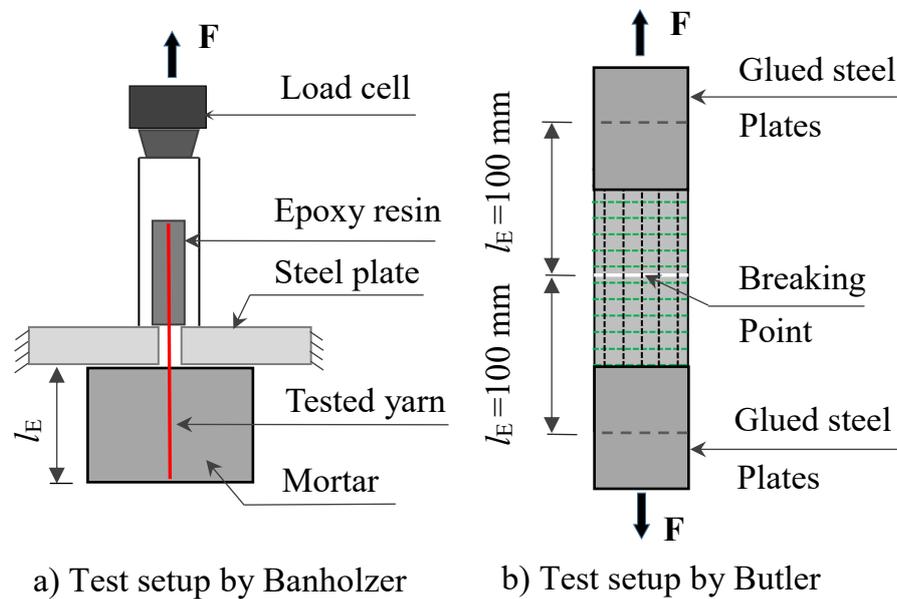
Figure 3.1 – Setups of pull-out test proposed by Banholzer (2006) and Butler (2010)

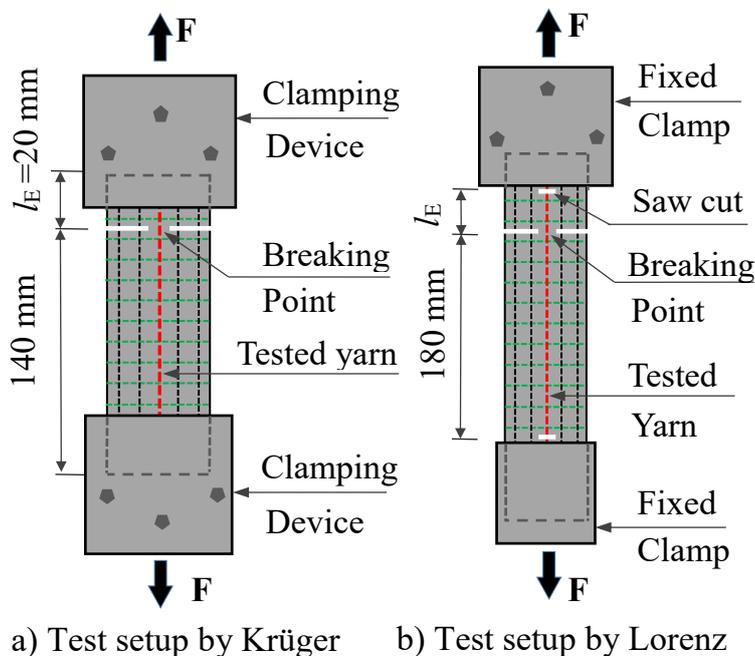
The setup of the pull-out test in this publication referred to the principle approaches of the research proposed by Lorenz and Ortlepp (2012). This study aimed at evaluating the bond behavior of the textile reinforcement and cement matrix in TRC. Tests with different embedded lengths were conducted to characterize failure modes of textile roving as well as obtain a representative trend of pull-out behavior.

Figure 3.2 – Setups of pull-out test proposed by Krüger (2004), and Lorenz (2012)

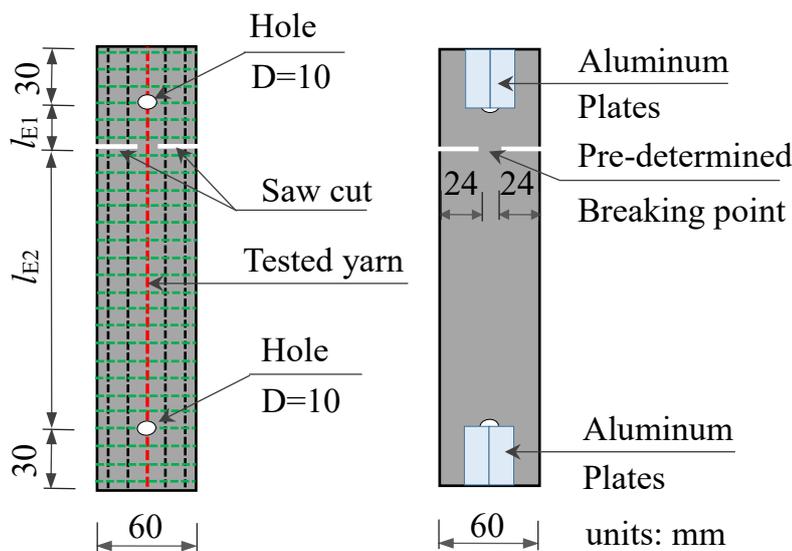
During the pull-out test, only one individual yarn (warp yarn) of the specimens was tested. Each specimen might be divided into three parts: the upper part and the lowest part used for clamping, whereas the middle one was the tested area where the pull-out failure of yarn carried out (see Figure 3.3). These parts of the specimen were separated by two holes with a diameter of 10 mm. At the position of the holes, the tested yarn also was cut, which ensure the pressure from clamp devices not affect the result of the test. In the tested area, there were two different types of the embedded length of warp yarn: the short and long anchorage length that was split up by the saw cuts on both sides of the specimen. These saw cuts with a width of 24 mm were created and controlled by wet saw cutter. They not only played the role of isolating tested yarn but also created the pre-determined breaking point of the specimen. The short anchorage length l_{E1} limited by the upper hole and the pre-determined breaking point. Besides, the length l_{E1} should not be smaller than 14 mm to ensure the safe handling of the specimen. If the distance of the adjacent transverse yarn is less than 14 mm, l_{E1} should be chosen as a multiple of this distance [Lorenz (2012)]. In this research, four different values of embedment length were chosen, the detail of the dimension of each type shown in Table 3.4. In contrast, the long anchorage length, l_{E2} , was defined by saw cuts and the second hole. This length must be sufficiently long to prevent the slippage at the free unloaded endpoint.

Figure 3.3 – Sketch of specimen used for pull-out test

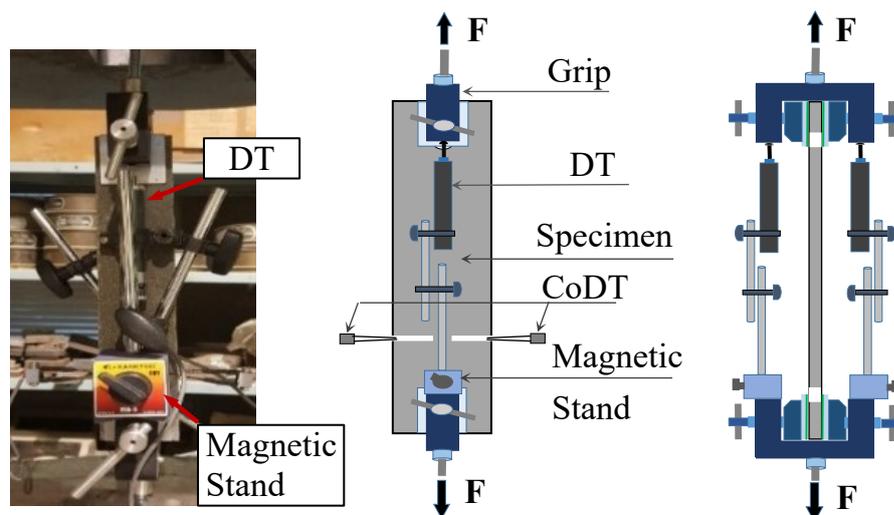
The test setup is shown in Figure 3.4. Before testing, aluminum plates were attached to both sides of the ends of the specimens by glue. These plates prevented the damage of concrete under the consequence of the direct lateral pressure of grips. The tensile load was applied via clamping devices on the upper and lower ends of the specimen. The type of used clamping device was a flat chuck tensile grip that had a flexible connection to the testing machine. The contact pressure was set in such a way that the slippage between clamp and specimen prevented, and the compressive strength of mortar was not exceeded. On top of the upper grip, a load cell with proper capacity was placed in order to measure the value of tensile force. The total deformation of the specimen measured by using two Displacement transducers (DT) placed on either side of the specimen. At the position of pre-determined breaking point, two Clip-on Displacement Transducers (CoDT) were arranged to determine crack-opening displacement.

Figure 3.4 – Setup of pull-out test

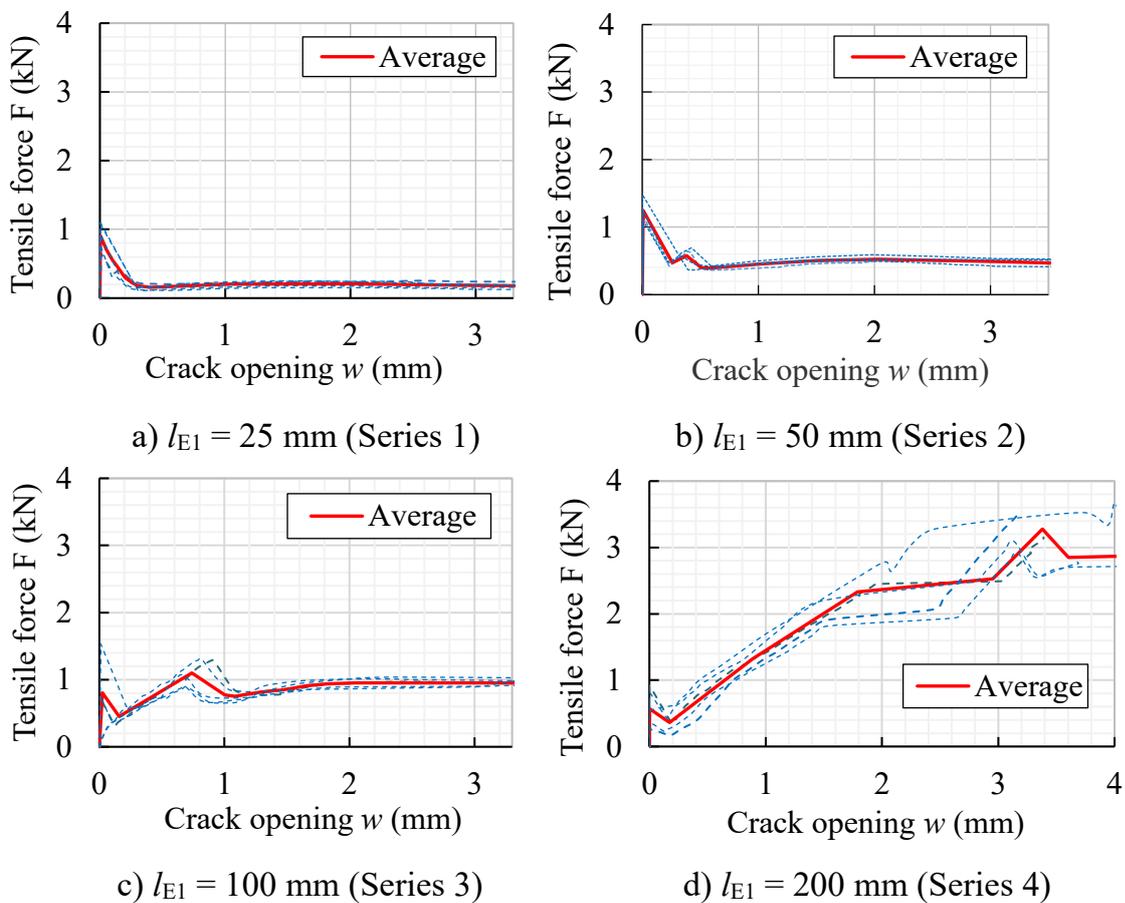
The result of the pull-out test was a force–crack opening and force – total displacement relationship, which shown in Figures 3.5 and 3.6, respectively. The increase of the pull-out force combined with larger displacement was observed when the embedded length increased. Besides, the dominant failure mode was pull-out of multifilament yarns in surrounding mortar (Figure 3.9) when 19 out of a total of 20 specimens occurred in this failure mode.

Figure 3.5 – Tensile force-crack opening relationship

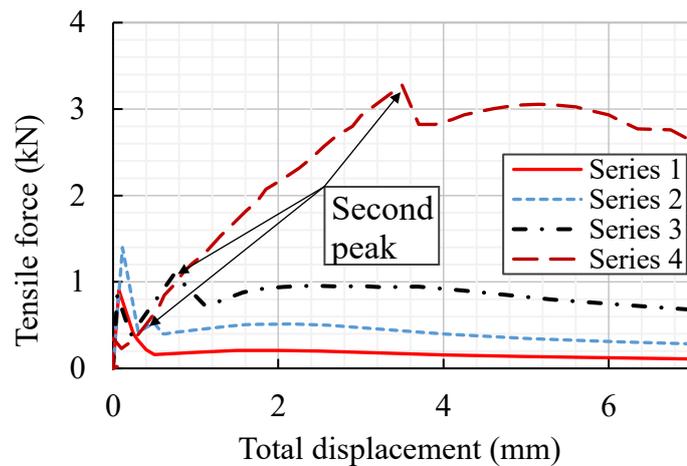
Figure 3.6 – Average tensile force-total displacement

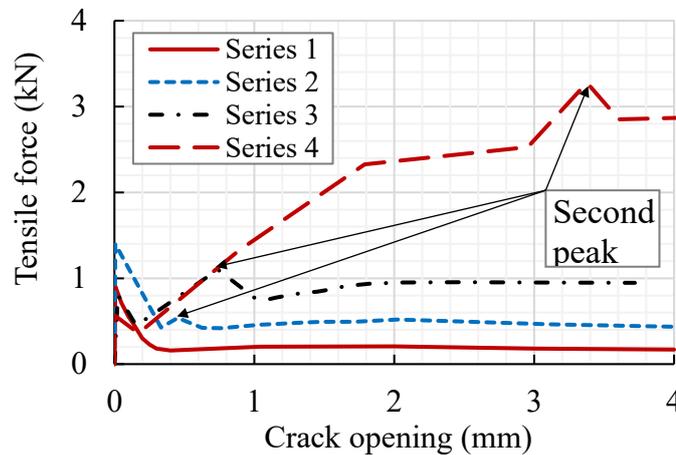
Figure 3.7 – Average tensile force-crack width

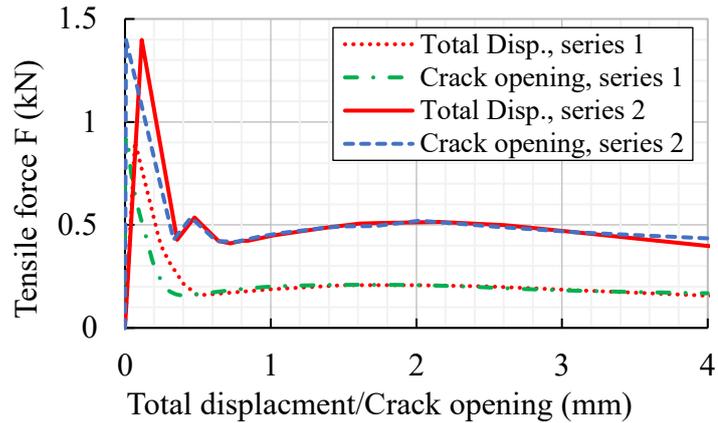
The significant difference between the crack opening and total displacement, measured by CoDT and DT, respectively, might be observed in Series 1 and 2 (see Figure 3.8). Before the crack of mortar occurred, with the same tensile force level, the total displacement of the specimen was always higher than the value of crack opening. This deviation was due to the elastic elongation of the specimen under the impact of the tensile force. This deviation tended to steadily decrease together with the increase of crack opening and the transmission of tensile forces to roving. In the activated state of the adhesive bond and friction bond, both CoDT and DT gave the approximately equal value.

Figure 3.8 – Correlation between total displacement and crack opening of Series 1 and Series 2

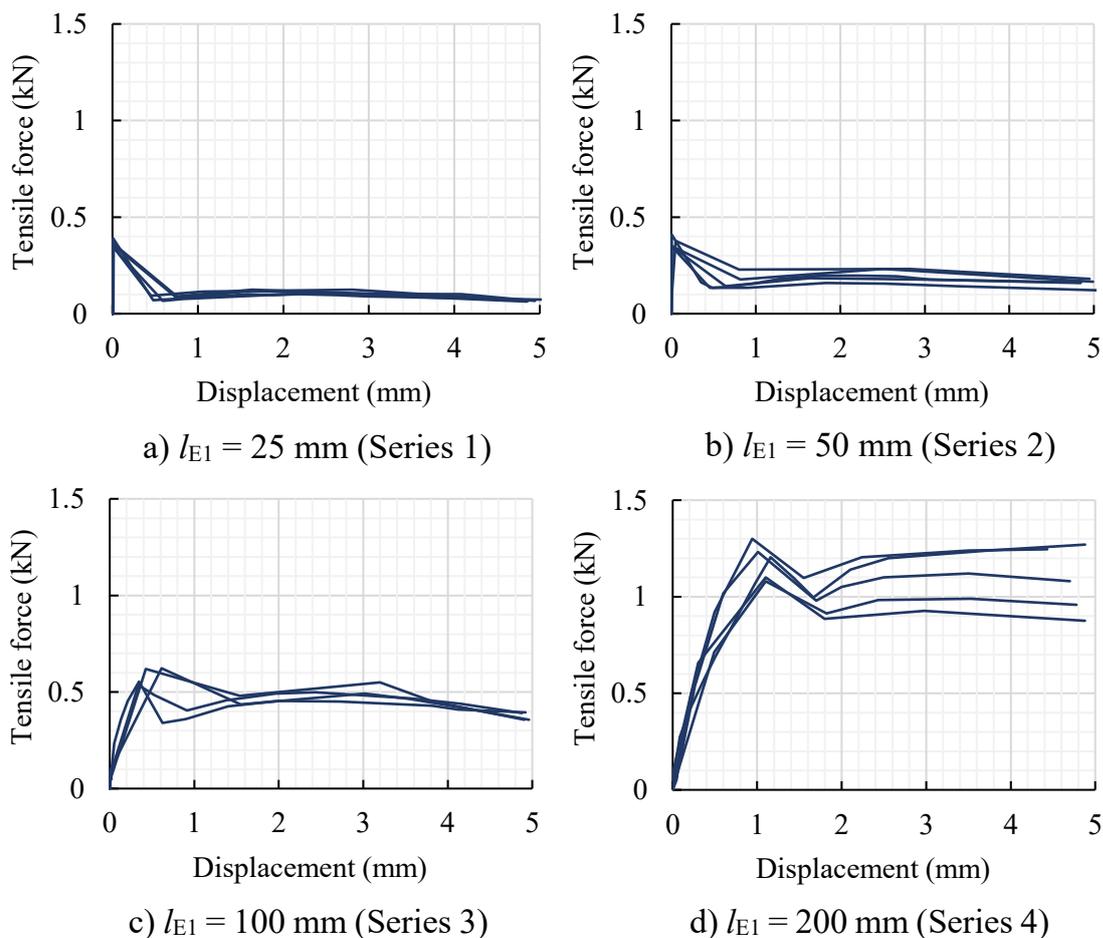
Figure 3.10 shows the tensile force-crack width relationship between the low strength ordinary mortar and textile of four different embedment lengths, including 25, 50, 100, and 200 mm. For Series 1 and Series 2, it can be seen that the peak loads are almost equal, and pull-out failure occurred simultaneously with the formation of the crack, which leads to the inability to determine the bond strengths. Besides, in the post-crack stage, the frictional forces of Series 1 and Series 2 are 0.1 and 0.2 MPa, respectively. The frictional forces increased linearly when then the embedment length increase from 25 mm to 50 mm. For Series 3 and Series 4, it is possible to determine the peak loads corresponding to the bond strength between textile and mortar. However, as shown in Figure 3.11 c and d, the peak loads are not much higher than the associated frictional forces. It suggests that the bond strength mainly based on friction between textile and mortar, whereas the contribution of mechanical and chemical adhesion is insignificant.

Figure 3.10 – Tensile force-Crack width relationship between textile and low strength ordinary mortar

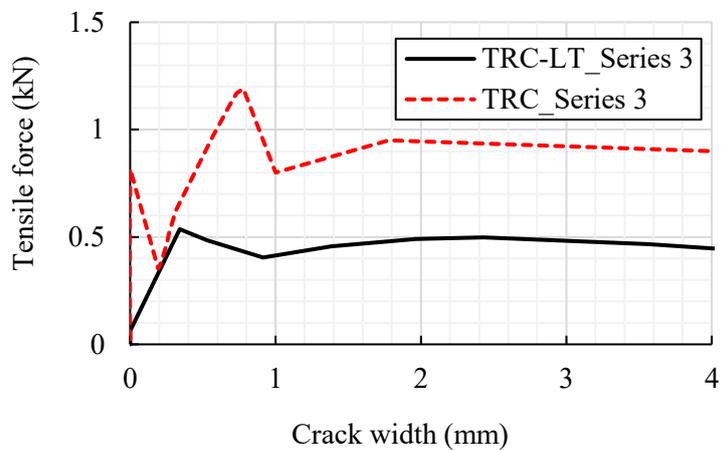
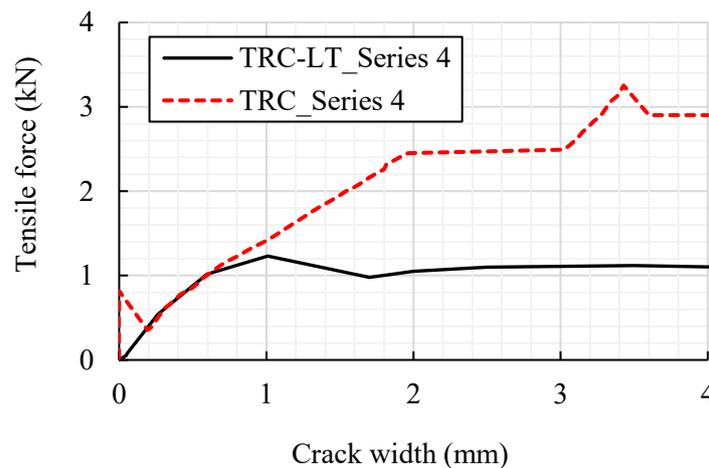
Compared with high strength ordinary mortar, specimens made of low strength ordinary mortar feature much less bond strength (see Figure 3.11). For example, in the case of Series L100, the peak load and the frictional force of TRC specimens are two times greater than those of TRC-LS specimens (Figure 3.11a). Even, this superiority of TRC specimens increases significantly in Series 4 with larger embedment lengths (Figure 3.11b). Besides, due to the weak bond strength between the textile and low strength ordinary mortar, the TRC-LS specimen failed with a relatively small slip of the textile. In terms of bond mechanism, TRC and TRC-LS specimens exhibit similar mechanisms, whereas the bond strength is major based on friction.

Figure 3.11 – Comparison of Tensile force-Crack width relationship between TRC and TRC-LS specimens

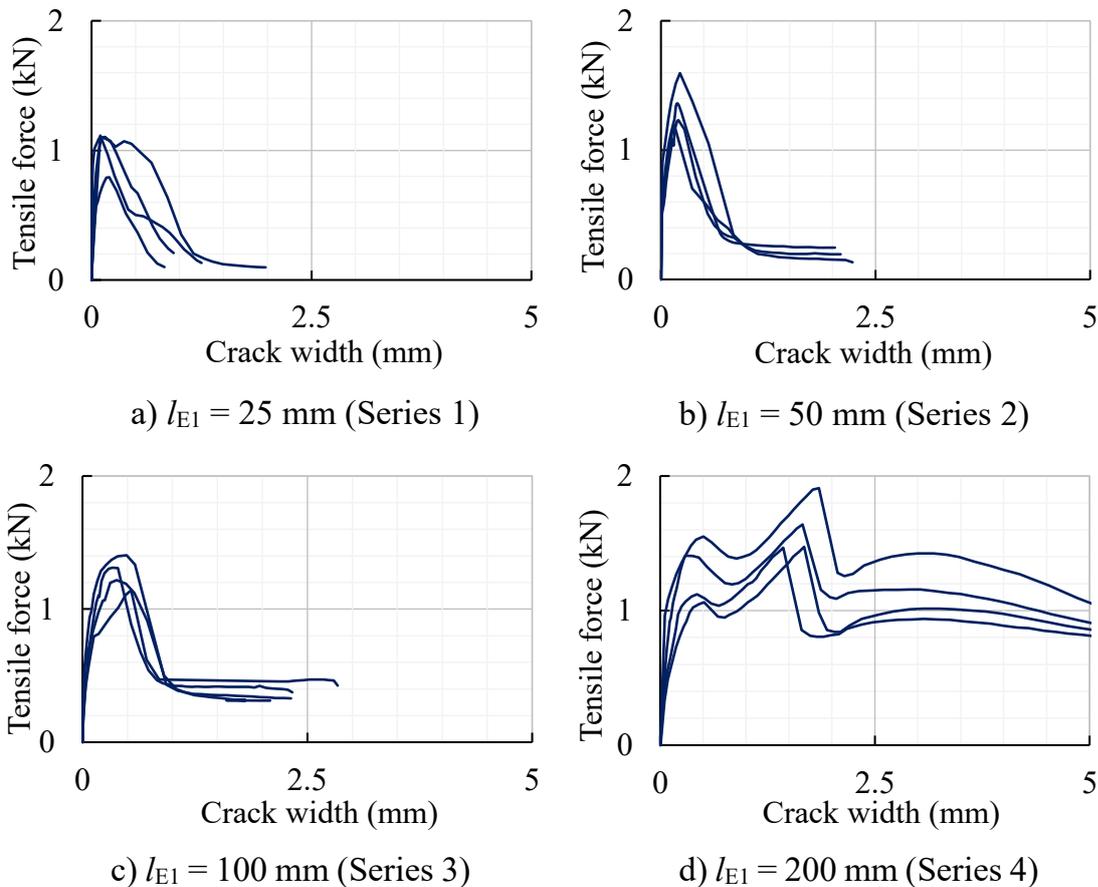
Similar pull-out tests were also conducted on specimens made of textile and SHCC (TR-SHCC). It can be observed from Figure 3.12 that dual peak response was not observed in Series 1, 2, and 3. For these series, the peak represented the crack of SHCC at the position of pre-determined breaking point as the strain of SHCC reached the ultimate value. The pull-out failure occurred immediately after the formation of crack, which depicted by a considerable plateau. Bond strength could not be determined for embedment lengths of 25, 50, and 100 mm. In the case of Series 3, although the embedment length of 100 mm was relatively large, the pre-peak response was not different from the series with much smaller embedment length. These indicated a weak bonding interaction between textile and SHCC, and the contribution of SHCC to pre-peak response was primary. The contribution of bonding, particularly friction bonding, could be observed more remarkably during the post-peak stage. It can be seen that when pull-out failure occurring, the tensile force increased linearly with the increase of embedment length (see Figure 3.12).

Figure 3.12 – Tensile force-crack width relationship of TR-SHCC

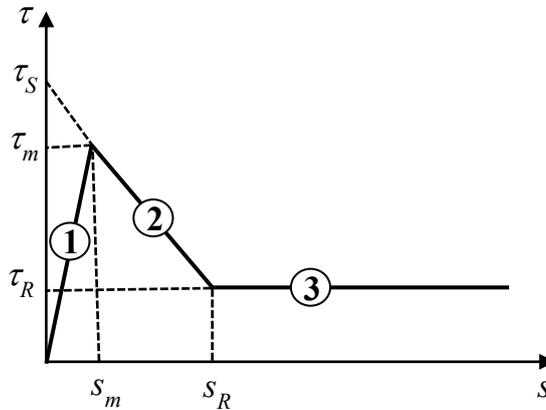
Figure 3.15 – Triple linear section of shear stress-slip relationship

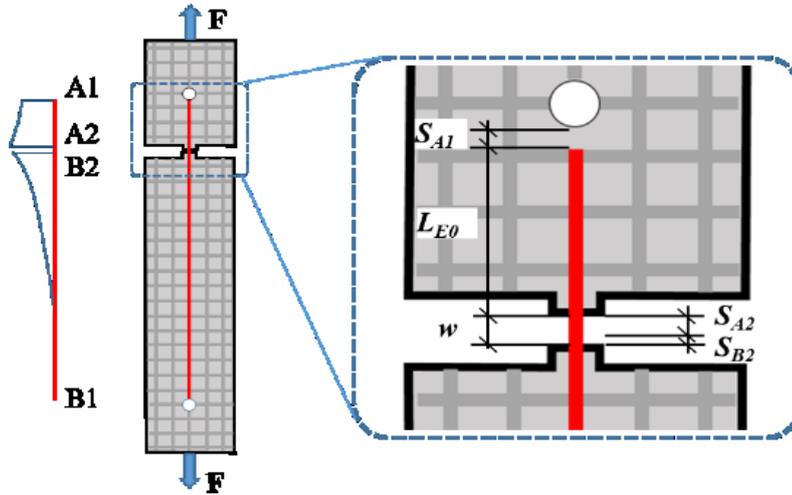
Figure 3.16 – Pull-out failure of warp yarn

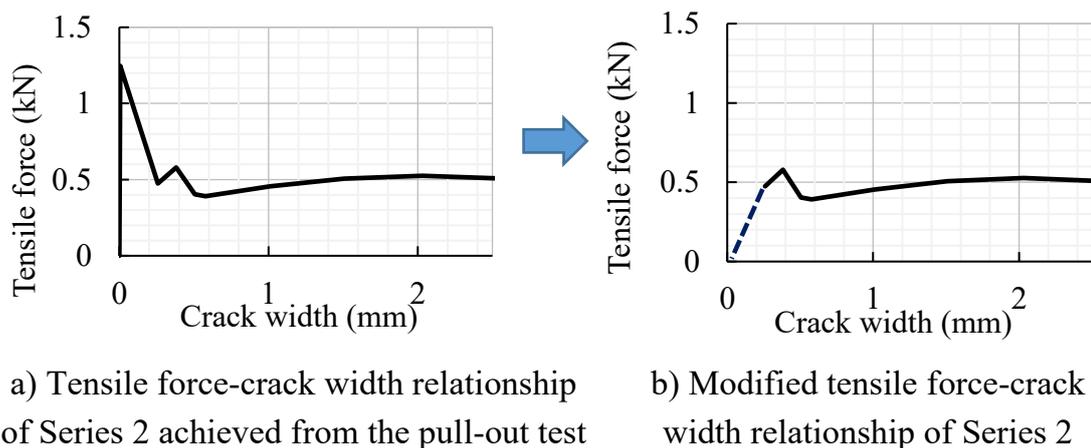
Figure 3.18 – Tensile force-Crack width relationship used to determine BSR

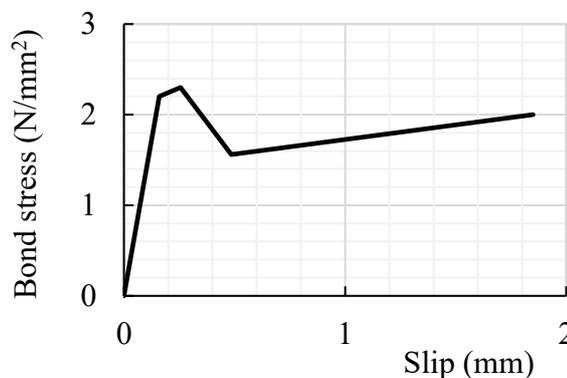
In this section, the bond stress-slip relationship is determined using the solution mentioned above. The determination of the bond stress-slip relationship should be based on a series with short embedment length. For TRC specimens made of high strength ordinary mortar, Series 2 with an embedment length of 50 mm is the most suitable. At first, the modified force-crack width relationship of Series 2 is defined by removing lines represent crack formation at the predetermined breaking point of the experimental tensile force-crack width relationship (Figure 3.18). Assume in advance a BSR, then using Equations 3.8-3.16 to calculate values F , S_{A2} , S_{B2} , Δl , and w (Table 3.6). The measured and calculated force-crack width curves show a good agreement, which indicates the assumed BSR is appropriate (Figures 3.19 and 3.20).

Figure 3.19 – Assumed BSR of high strength ordinary mortar

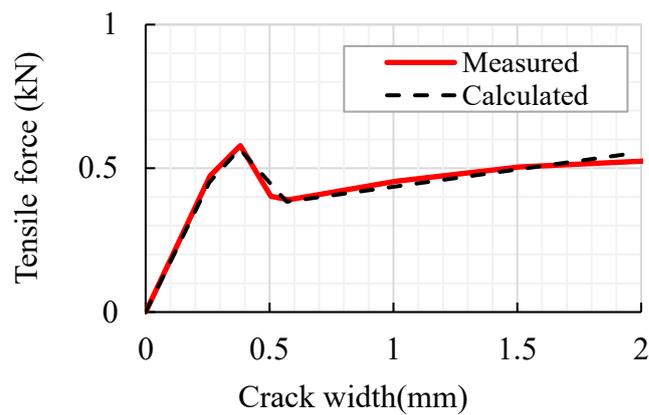
Figure 3.20 – Comparison between measured and calculated force-crack width relationship of Series 2

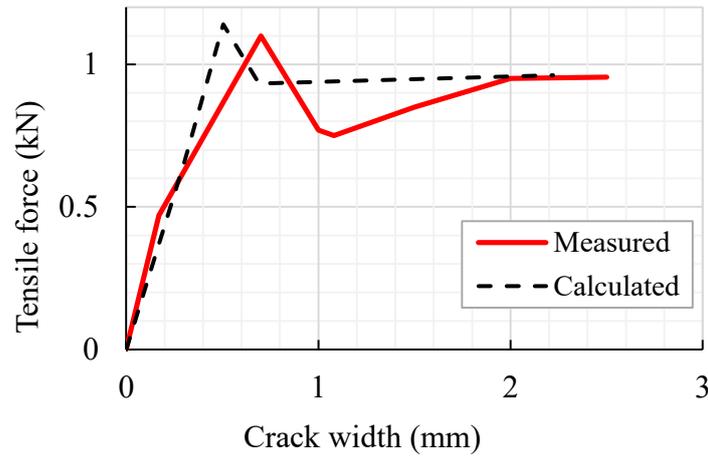
Figure 3.21 – Comparison between measured and calculated force-crack width relationship of Series 3

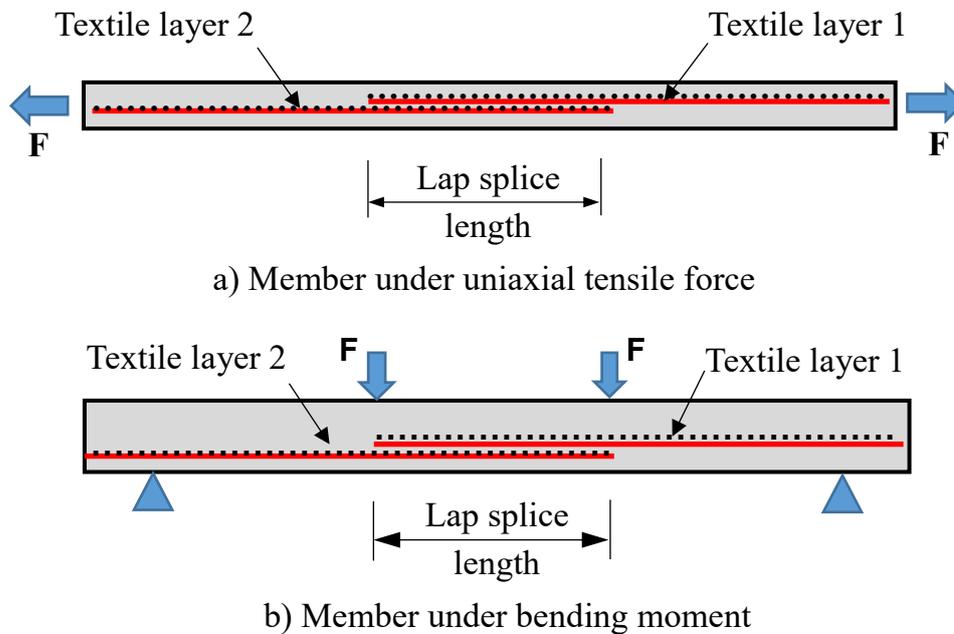
reinforcements. The lap splices are supposed to provide sufficient overlap length if they promote the failure of textile reinforcement before debonding of the overlapped textile fabrics [Donnini et al. (2019)]. Two types of members were examined: member under subjected to uniaxial tensile force and member under bending moment (see Figure 4.1).

Figure 4.1 – Types of tests

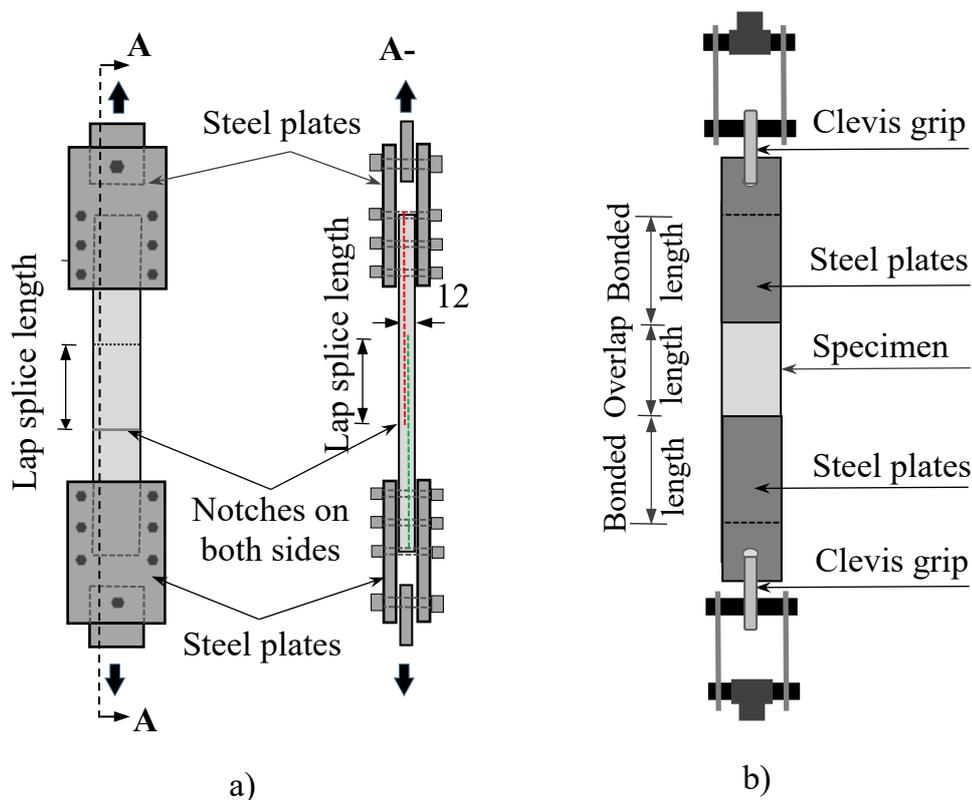
Figure 4.2 – Test setup of tensile test by Lorenz and Ortlepp (a) and by Donnini et al.

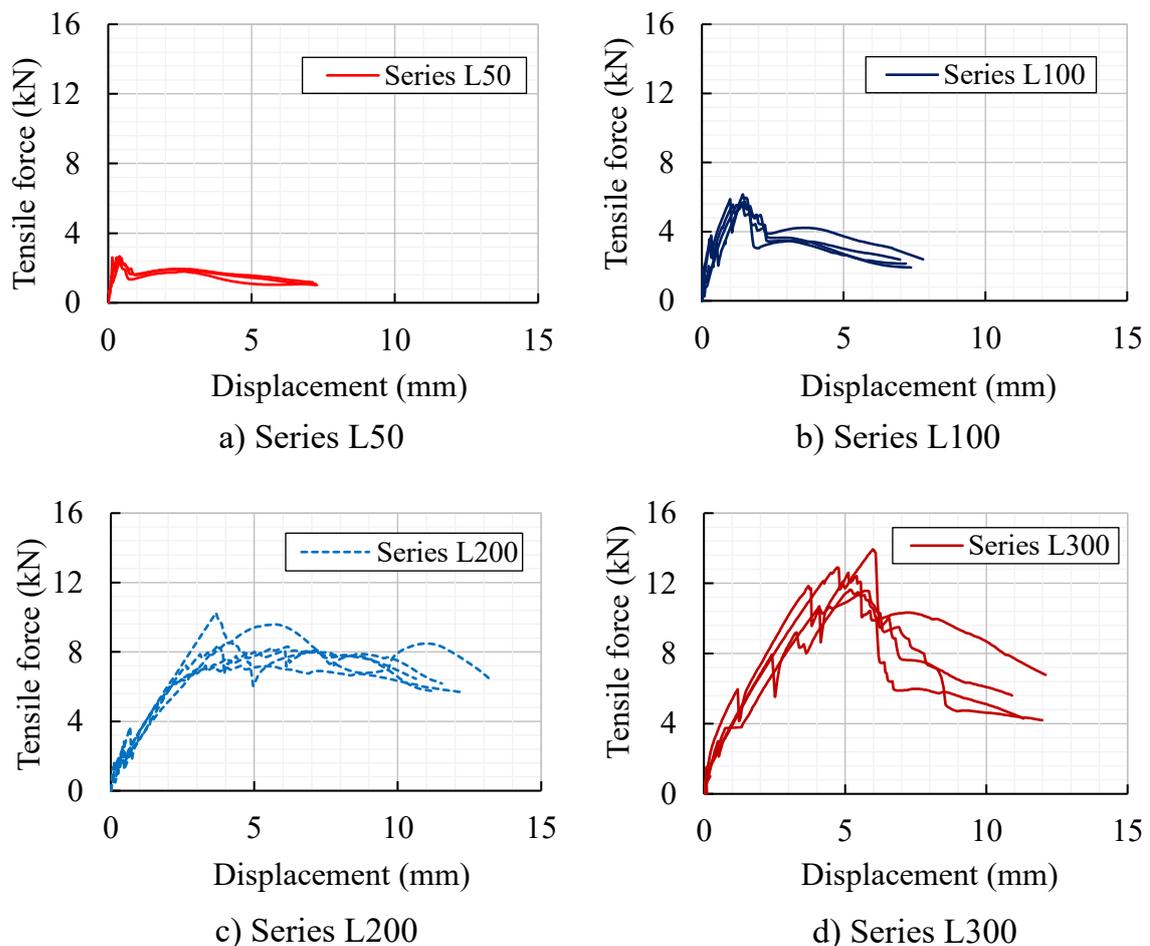
The results of the tensile test in terms of failure mode, failure load, and corresponding displacement were reported in Table 4.5. It is recognized that the load-bearing capacity of specimens increased steadily together with the increase of lap splice length. The specimens with lap splice length of 300 mm (Series L300) provided the highest tensile capacity, whereas the specimens of Series L50 possessed the lowest efficiency. Besides, different failure modes were observed, including pull-out and delamination failures, but the breakage of textiles did not occur in all series.

Figure 4.6 – Tensile force-displacement relationship of series with lap splice

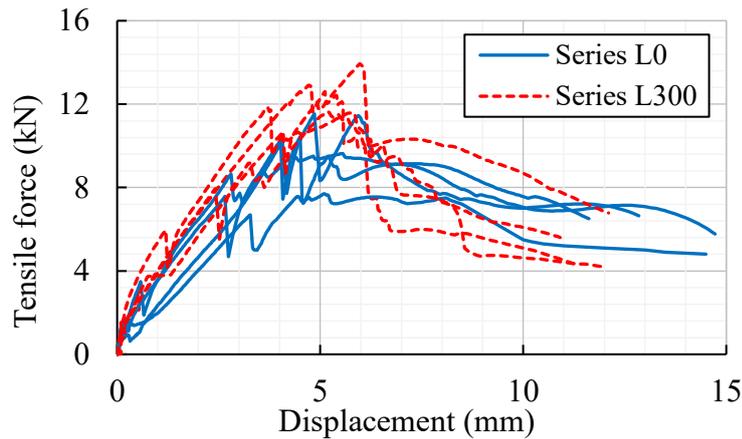
Figure 4.7 – Tensile force-displacement relationship of Series L0 and L300

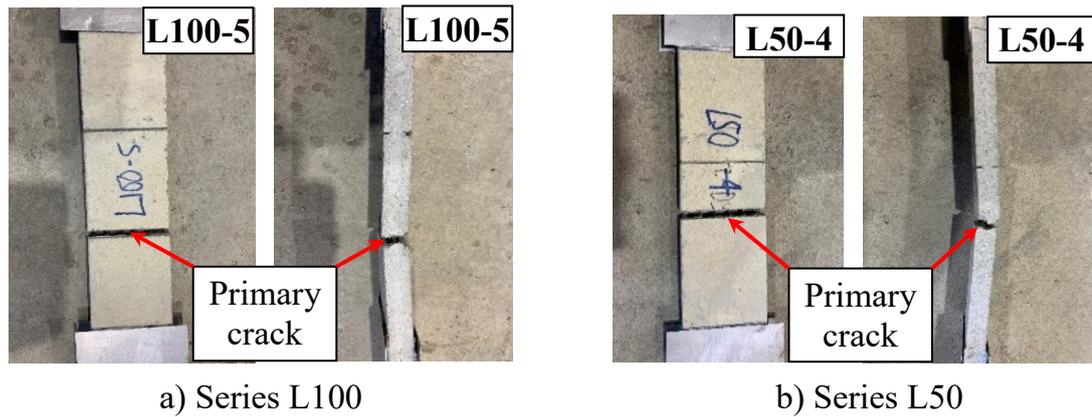
For the Series L100 and L50, the result showed that the lap splice lengths were not enough to guarantee the complete transfer of tensile stress from one fabric to another. Fabrics slip on each other, and pull-out failure was the dominant failure mode in all specimens (see Figure 4.8). Consequently, the tensile capacity of the specimens significantly small. The average load-bearing capacity of Series L100 and L50 were 5.5 kN and 2.6 kN, respectively, much less than that of controlled Series L0 (10.1 kN). The tensile force-displacement curves of the two series in Figure 4.9 showed that the shape of these curves was quite similar, with a considerable plateau in the failure phase. These plateaus represented the friction between fabric and mortar as the pull-out failure occurring.

Figure 4.8 – Pull-out failure of Series L100 and L50

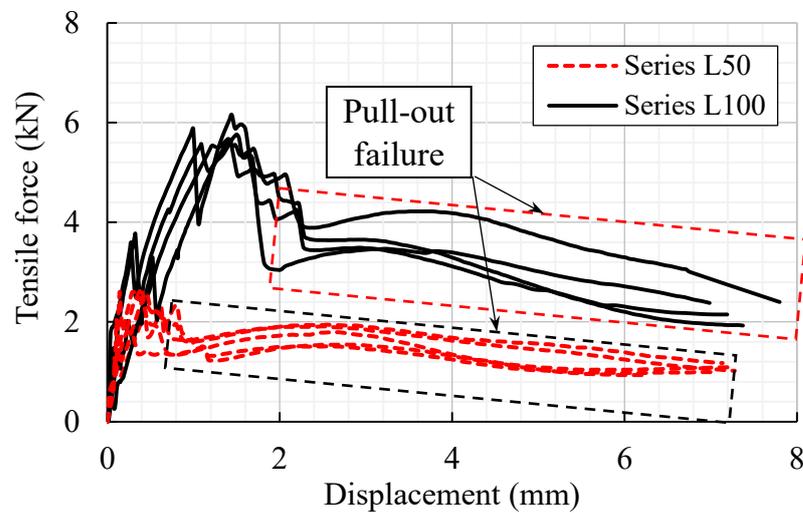
Figure 4.9 – Tensile force – displacement relationship of Series L100 and L50

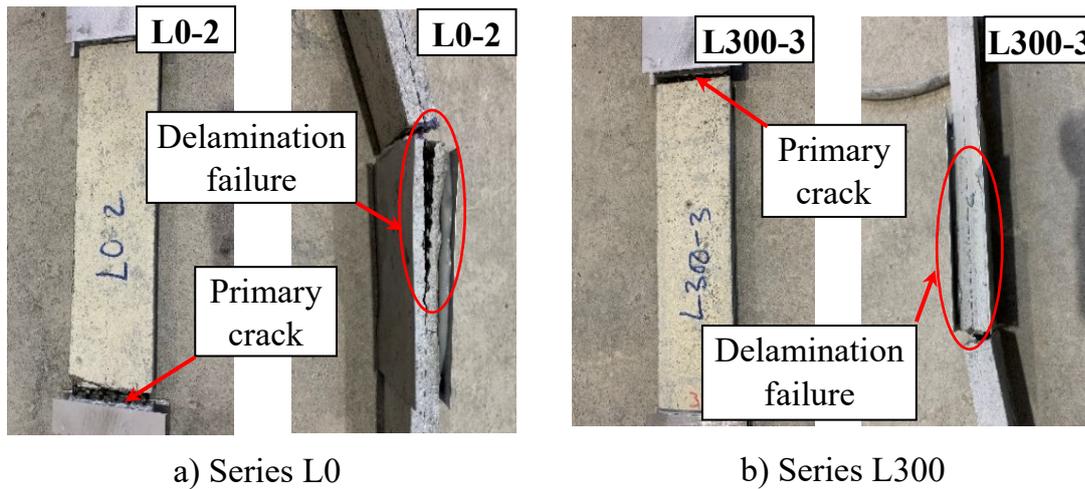
Increasing the lap splice length up to 300 mm allowed to achieve the specimen integrity and to reach ultimate load-bearing capacity approximately equal to that of the Series L0 with continuous textile reinforcement. Figure 4.7 showed that the tensile behavior of Series L300 was not so different compared to the behavior of controlled series. In addition, the delamination failure occurred in all specimens of both Series L300 and L0 (Figure 4.10). These indicate that the lap splice length of 300 mm secures to transfer effectively the tensile stress one fabric to the other.

Figure 4.10 – Failure modes of Series L0 and L300

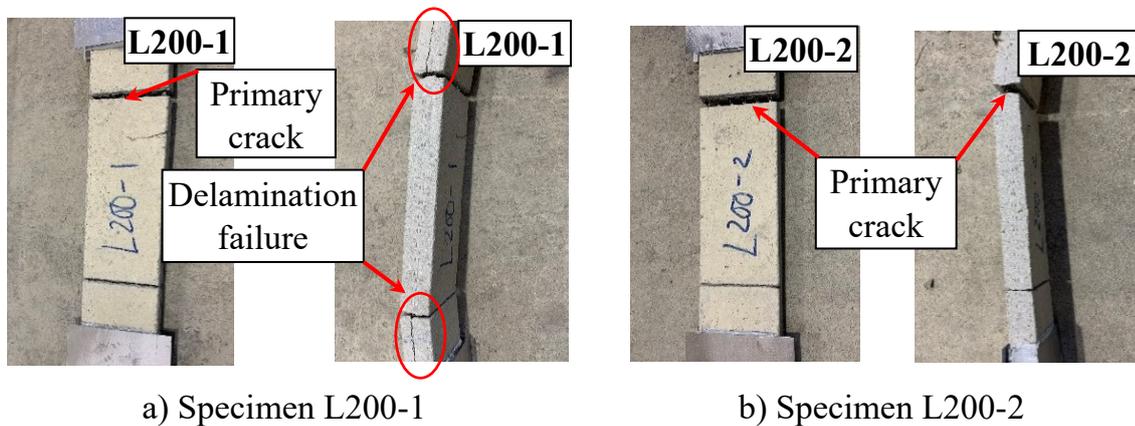
For the Series L200, the results showed a variety of failure modes. The delamination failure occurred in specimens L200-1 and L200-5, whereas the dominant failure mode of specimen L200-2, L200-3, L200-4 was the pull-out failure (see Figure 4.11). Besides, the average failure load of Series L200 was 8.6 kN, fairly smaller than the tensile capacity of reference series (10.1 kN). Therefore, it is reasonable to assume that the lap splice length of 200 mm is insufficient to achieve satisfactory performance.

Figure 4.11 – Different failure modes of Series L200

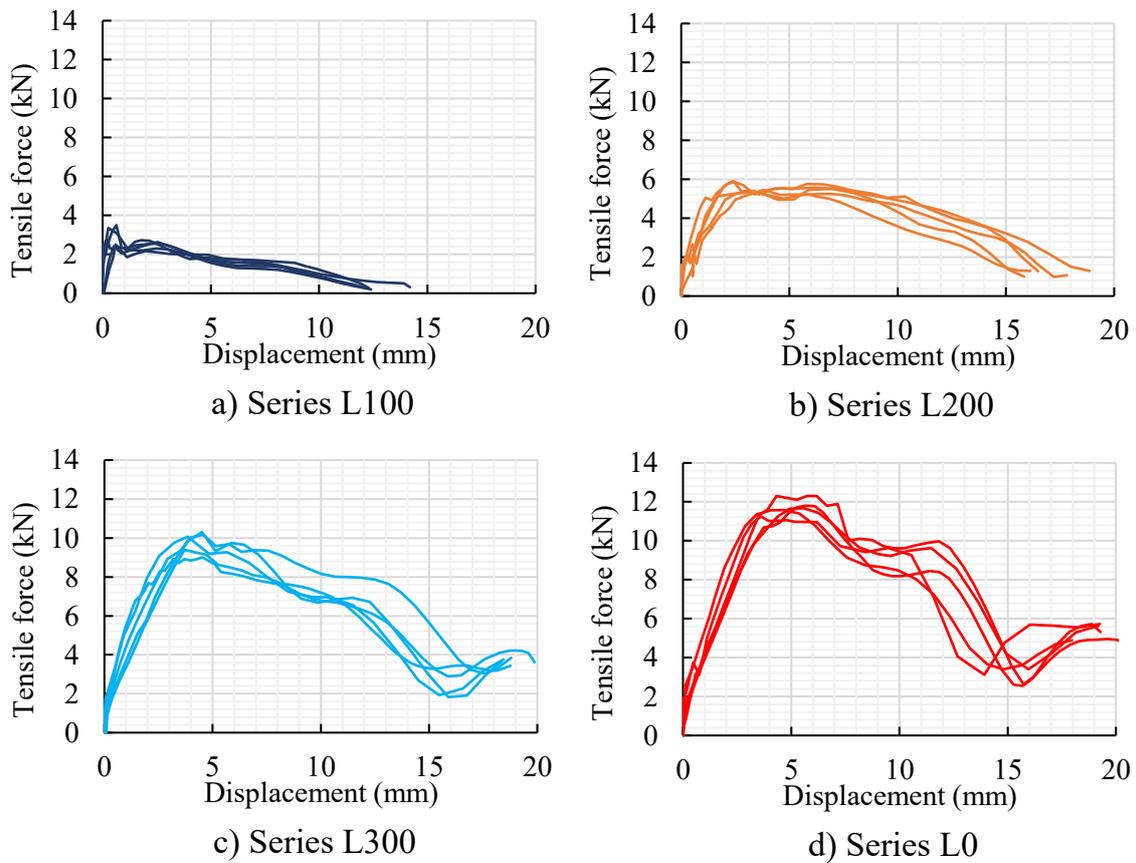
mm are inadequate. For Series L300, the average peak load is 9.5 kN, significantly higher than that of Series L100 and Series L200. However, compared to the control series, the peak loads and corresponding displacement of Series L300 are still rather smaller than those of the control series. Besides, the dominant failure of Series L300 is pull-out (see Figure 4.14), which is different from the delamination failure of Series L300 made of SHCC or high strength ordinary mortar. Therefore, the combination of textile and low strength ordinary mortar requires an adequate lap splice length greater than 300 mm.

Figure 4.12 – Tensile Force-Displacement relationship of TRC specimens made of low strength ordinary mortar

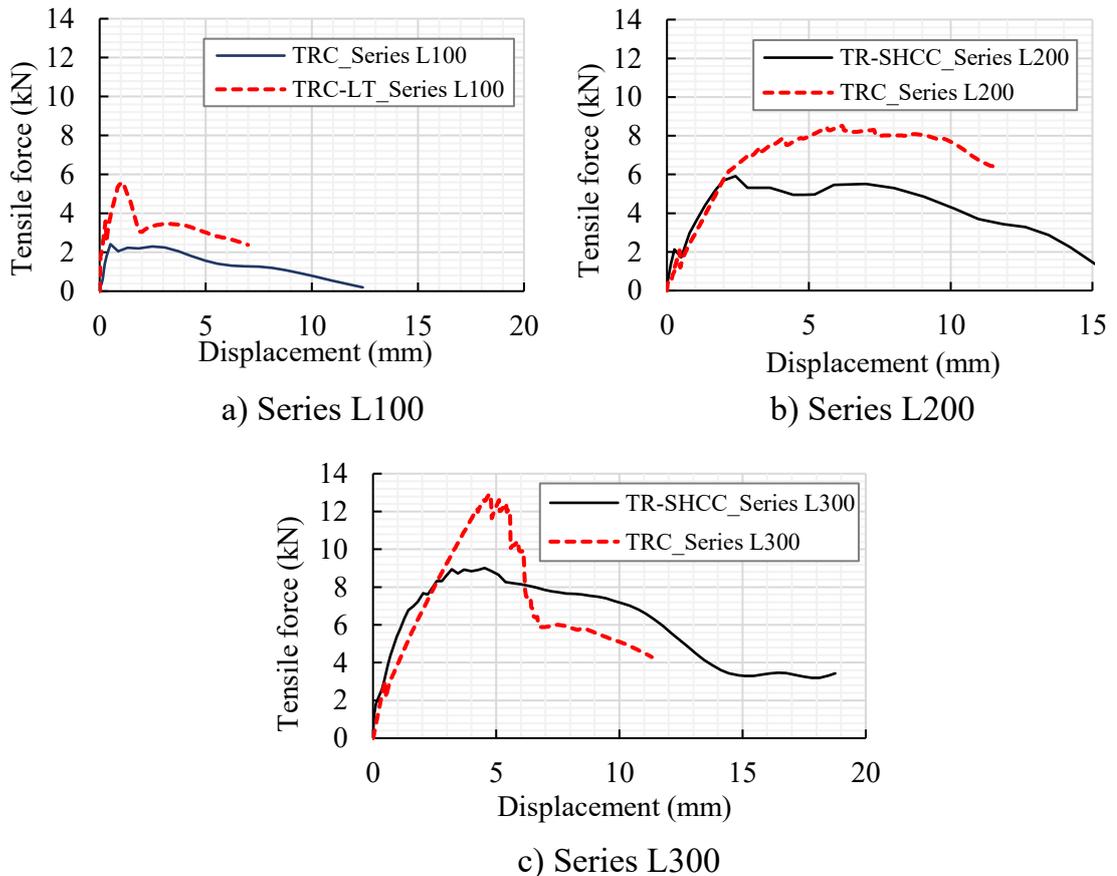
Figure 4.15 – Comparison of Tensile force-Displacement relationship between TRC and TRC-LS specimens
