DOCTORAL DISSERTATION

**STRUCTURAL DETAILS OF
TEXTILE REINFORCED
CONCRETE**

Mechanical and Civil Engineering Division
Graduate School of Engineering, Gifu University

BUI SI MUOI

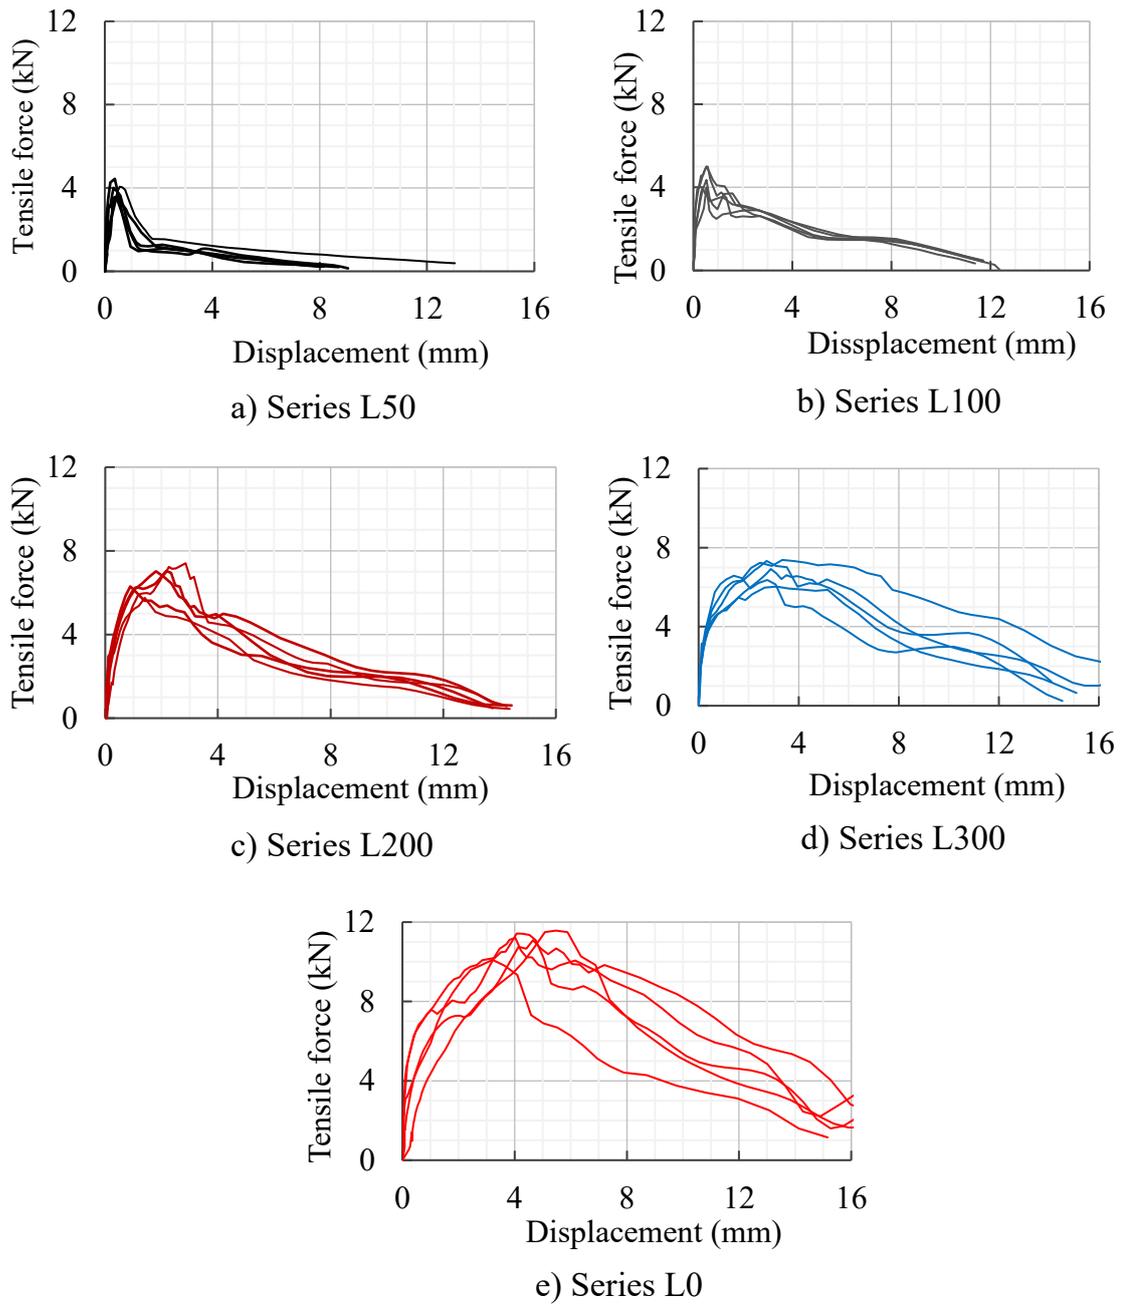
For controlled series L0, the tensile behavior of specimens with continuous textile reinforcement was described in Figure 4.16e and Figure 4.17. The cracks firstly appeared at positions of two notches when the ultimate tensile strength of the SHCC was achieved. Increasing tensile force, delamination failure occurred at the interface between SHCC layers and textiles. The splitting initially formed within the area between two notches, then extended to the end anchorage area. However, due to the effect of compression force from clamping devices which provided confinement action, the splitting did not spread to the ends of specimens. The delamination within the end anchorage area led to the shortening of anchorage length. As a result, the final failure mode was the mix of delamination and pull-out failure of textiles within the end anchorage area. Secondary cracks were also observed before the specimens reached the failure load. It showed the good bond conditions which ensure the stress transmission from textile reinforcement to the SHCC. Besides, the average failure load of controlled series and the corresponding stress of roving are 11.1 kN and 969 MPa, respectively. It indicates that the tensile stresses of the yarns are much smaller than the tensile strength of textile (1700 MPa), and the combination of textile and SHCC cannot exploit the capacity of textile reinforcement to its full extent.

Figure 4.16 – Tensile Force-Displacement relationship of TR-SHCC

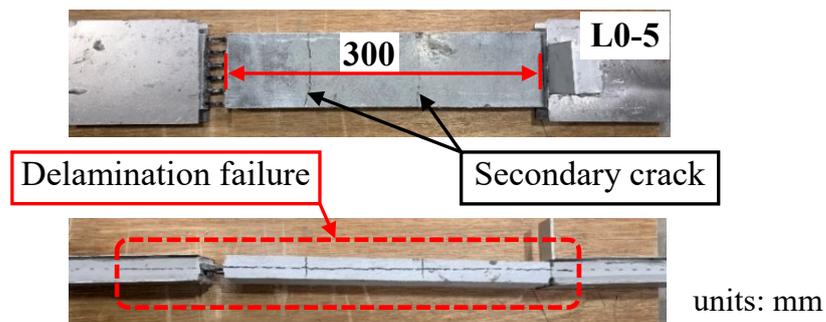
Figure 4.17 – Failure mode of Series L0

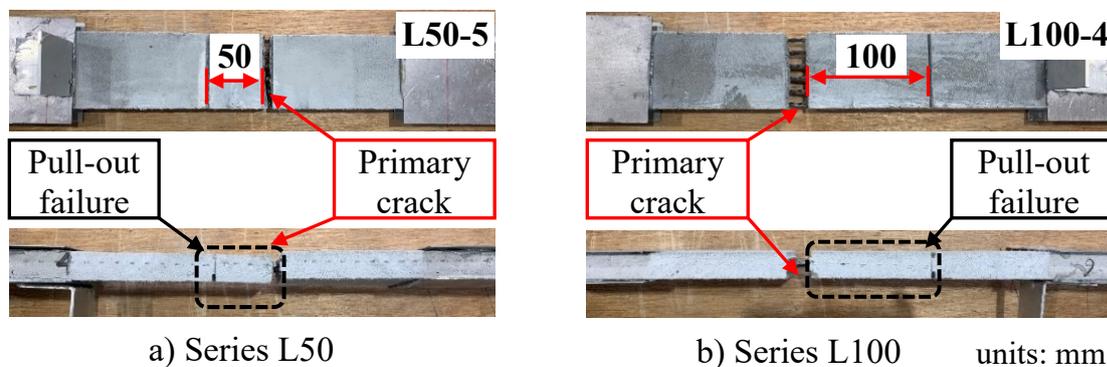
Results showed that the lap splice lengths of 50 and 100 mm (Series L50 and L100) are inadequate to establish satisfactory performance. Because of short lap splice length, only one crack could appear at one of the two notches, and pull-out failure had initiated before the second crack formed (see Figure 4.18). For series L50, the failure occurred simultaneously with the formation of crack. As a result, failure loads, as well as bond strength, were not defined. The bond between textiles and the mortar was only determined when textile reinforcements extracted from the mortar. In this stage, this bond based on the friction, which depicted by a considerable plateau. Compared to Series L50, Series L100 exhibited slightly different on behavior. As the crack had formed, the mechanical bond between matrix and reinforcement was activated that was depicted by an ascending branch of the load-displacement relation curve. After reaching the bond strength, the destruction of the mechanical bond occurred due to debonding of the yarn from the matrix. As a result, the pull-out failure occurs. Simultaneously, there is a significant increase in the relative displacement between textile reinforcement and mortar. Lastly, the remaining pull-out force was based on friction, which was identified by a considerable plateau. These characteristics of the pull-out failure in lap splice of members subjected to tensile forces are similar to the pull-out failure of lap splice that addressed in several pieces of research.

Figure 4.18 – Pull-out failure of Series L50 and L100

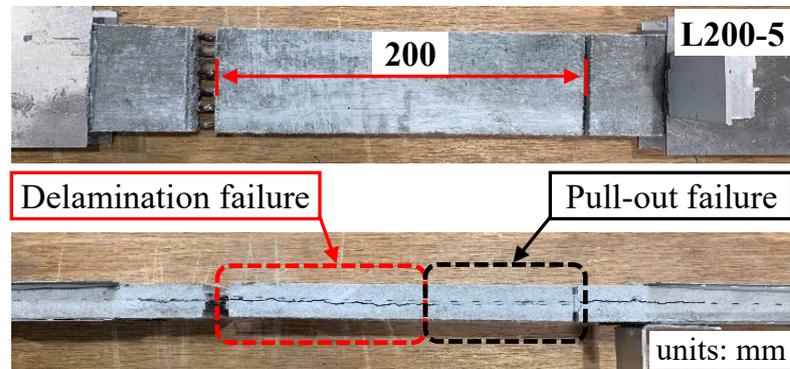
Figure 4.19 – Failure mode of Series L200

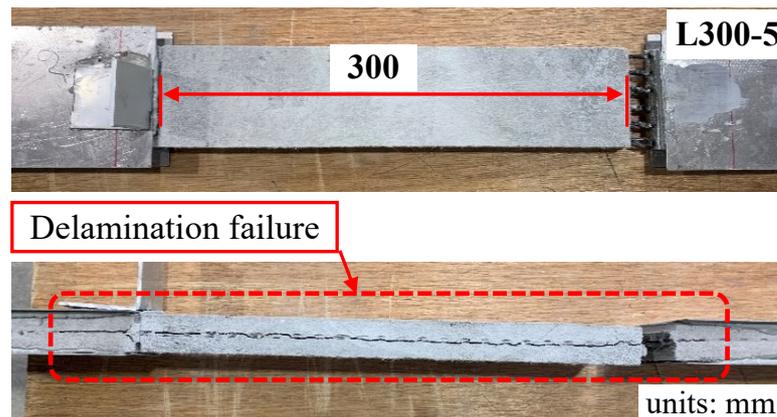
Figure 4.20 – Failure mode of Series L300

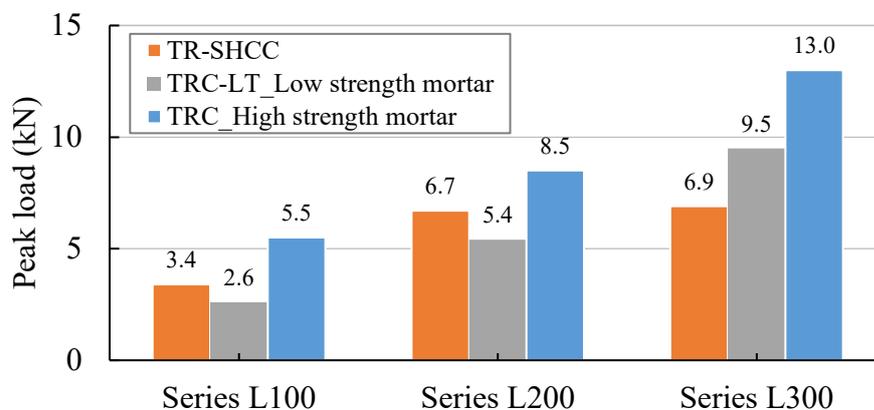
Figure 4.21 – Comparison the peak loads of specimens made of SHCC, low and high strength ordinary mortar

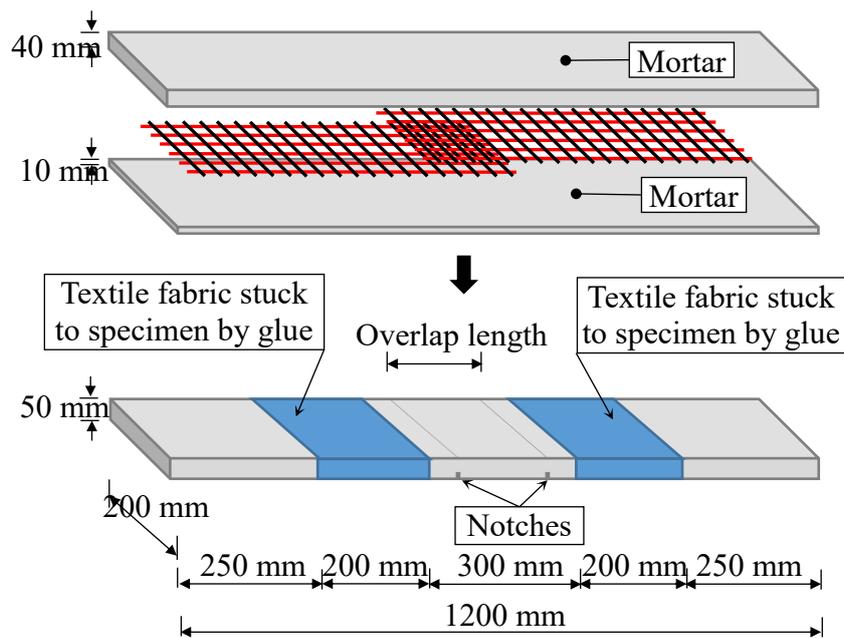
Figure 4.22 – Detail geometry of the specimens

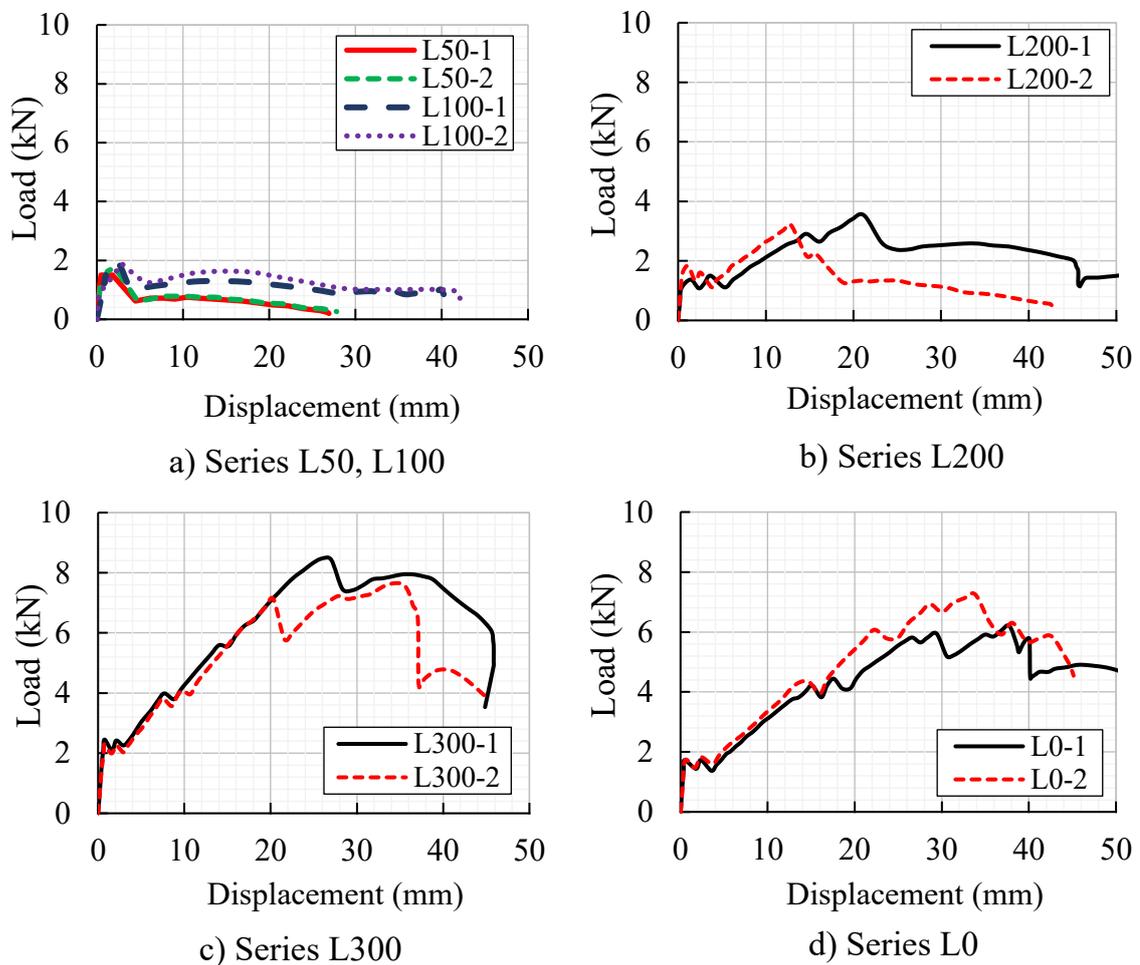
Figure 4.25 – Load - Displacement relationship

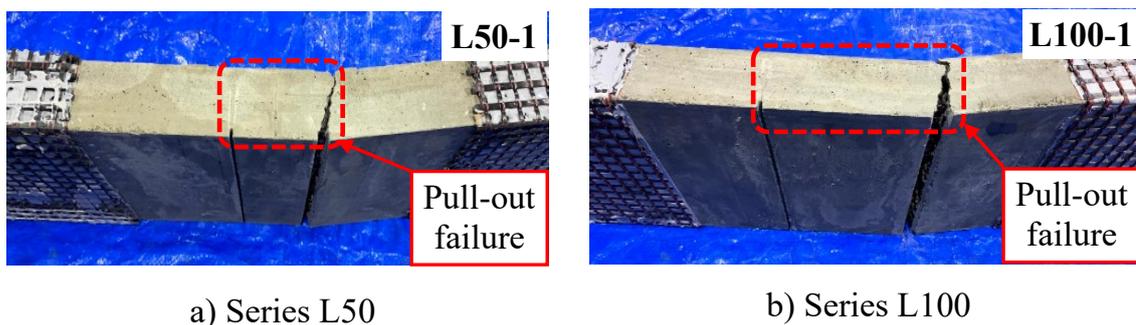
Figure 4.27 – Failure mode of series L50, L100

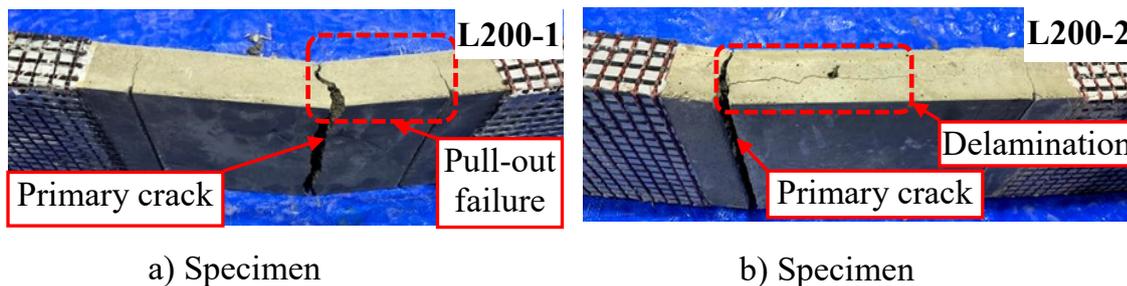
Figure 4.28 – Different failure modes of series L200

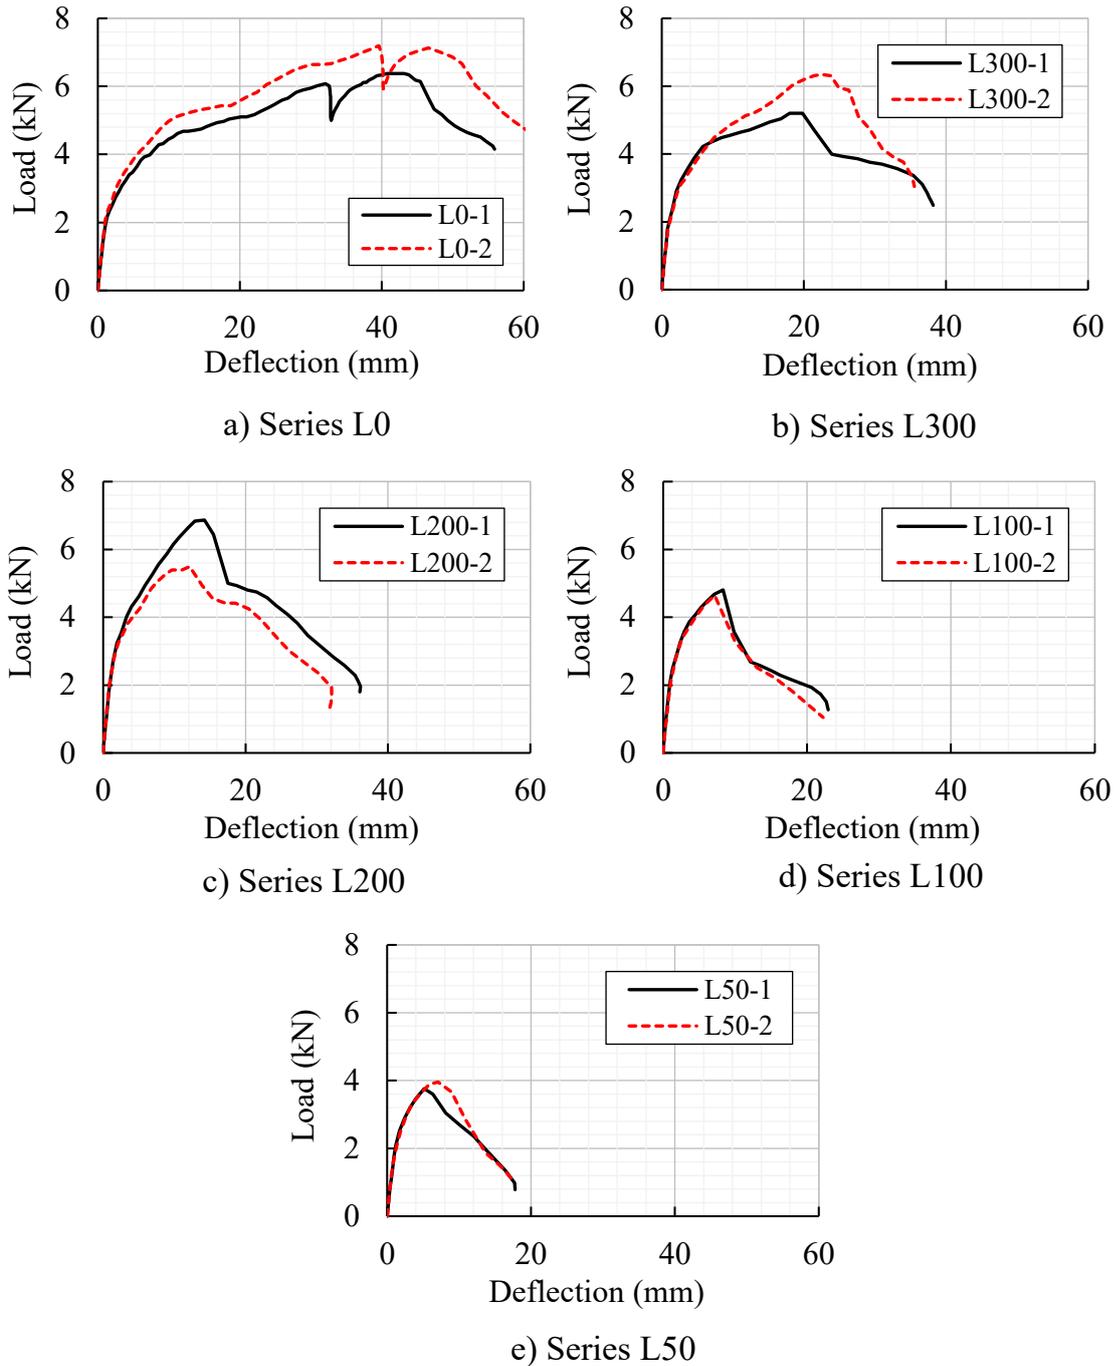
Figure 4.30 – Load-Deflection relationship of TR-SHCC beams

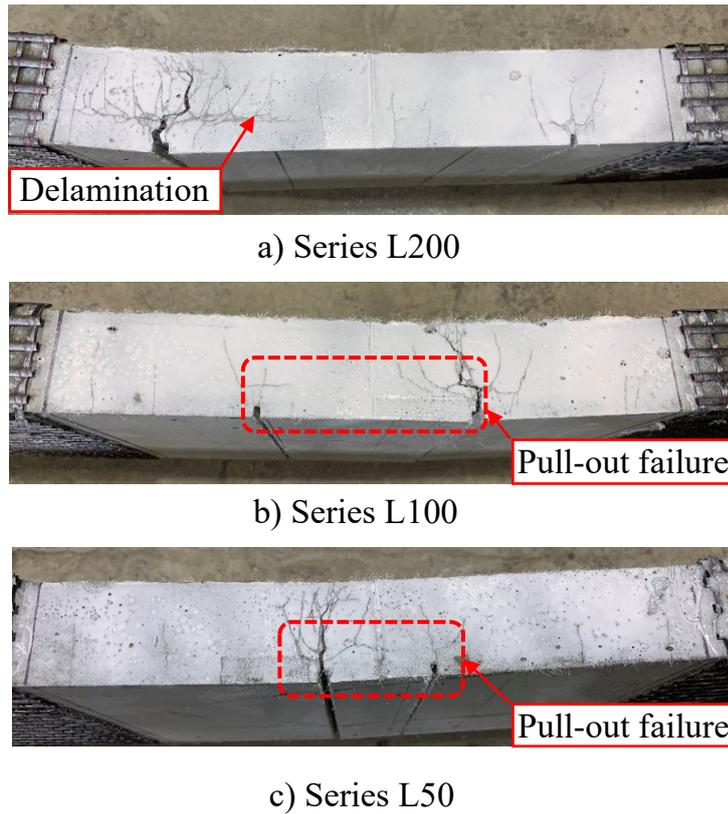
Figure 4.32 – Crack patterns of Series L50, L100, and L200

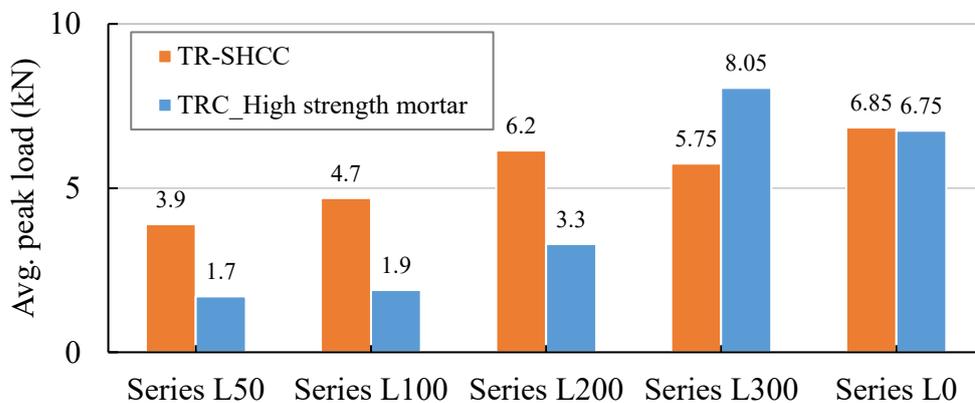
Figure 4.33 – Average peak load of TRC and TR-SHCC specimens

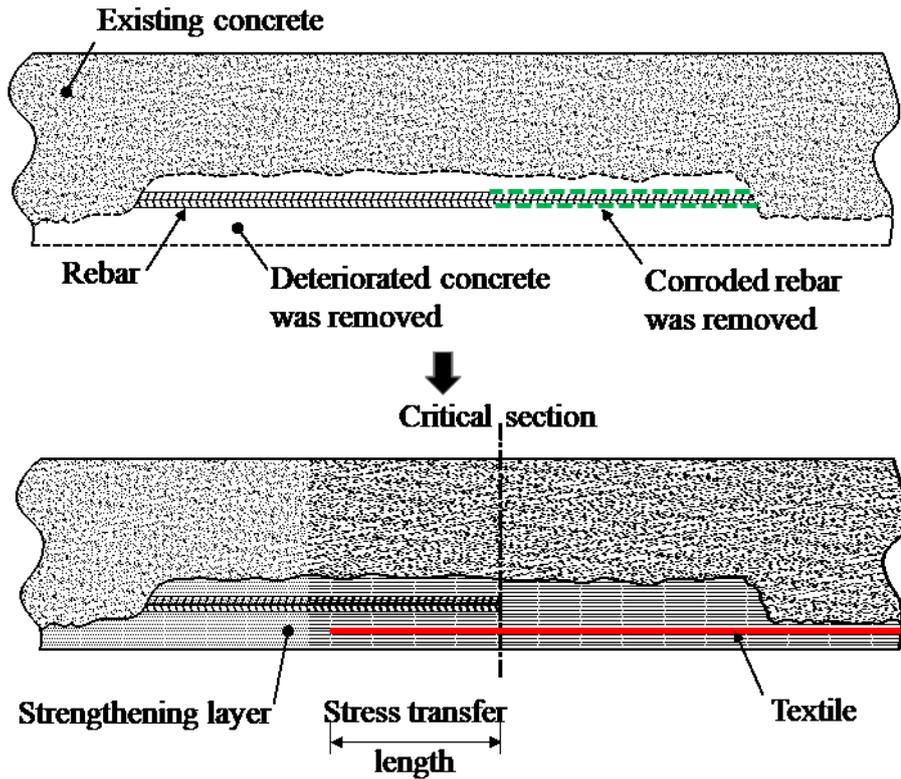
Figure 5.1 – Using TRC to repair existing flexural concrete structures

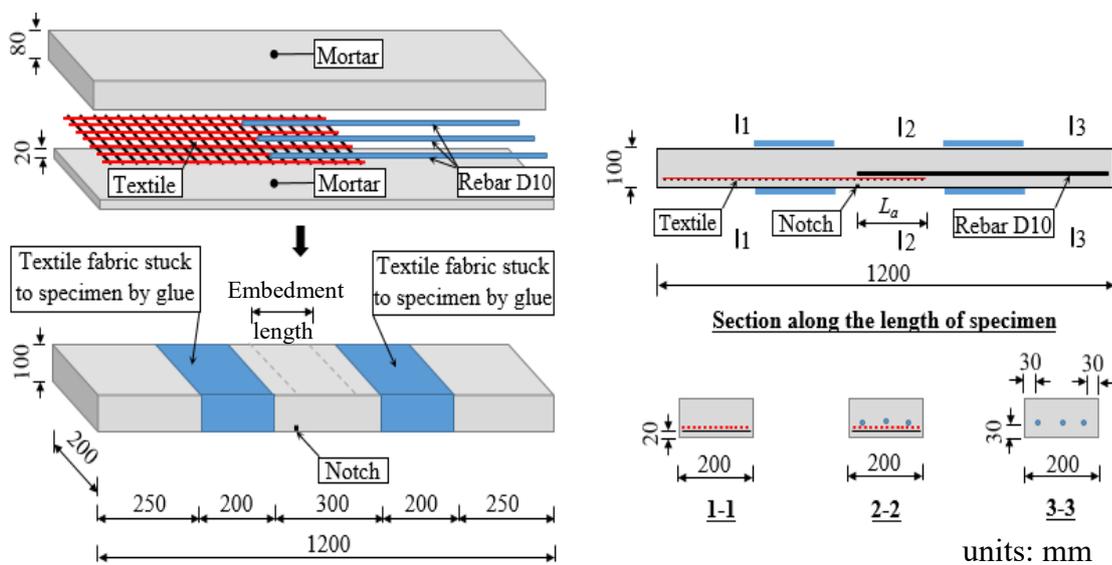
Figure 5.2 – Sketch of specimen used for flexural test

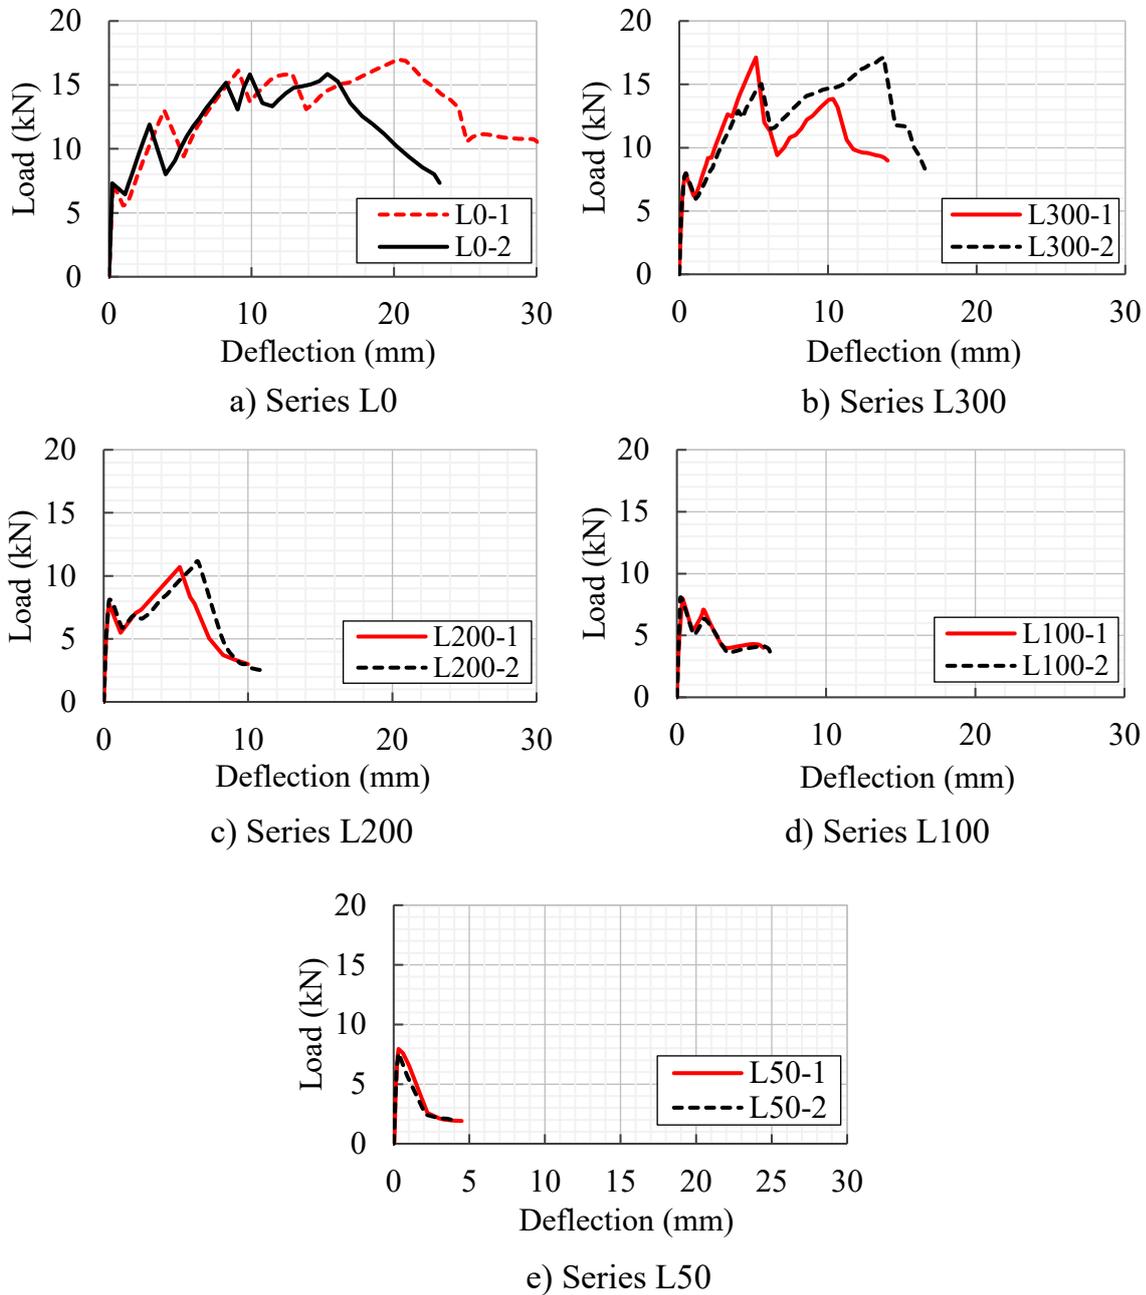
Figure 5.4 – Load-deflection relationship of all series

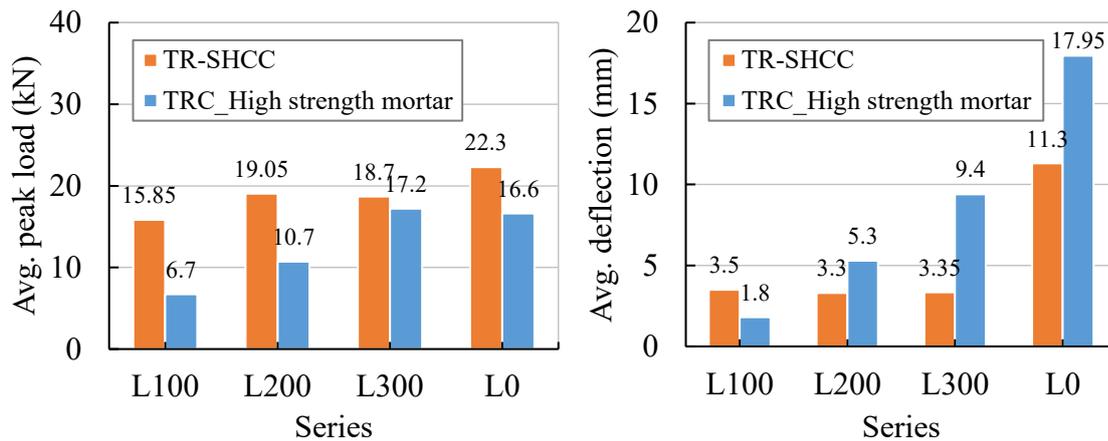
a) Average peak load of TRC and TR-SHCC specimens

Figure 5.10 – Comparison peak load and corresponding deflection of TRC and TR-SHCC specimens

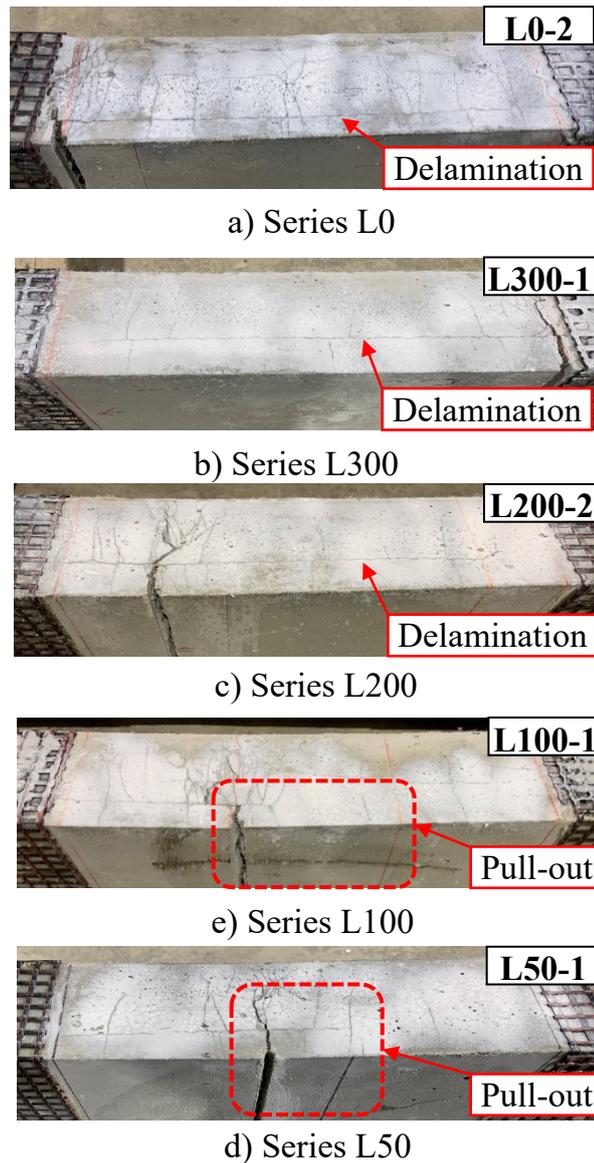
Figure 5.11 – Crack patterns of TR-SHCC specimens

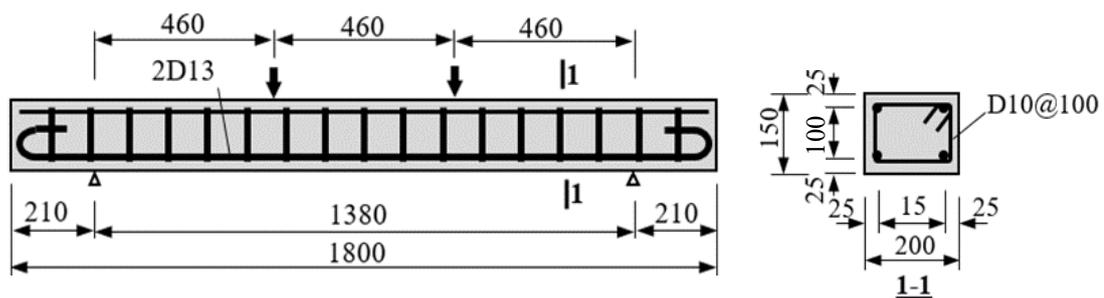
Figure 6.2 – Sketch of control beam units: mm

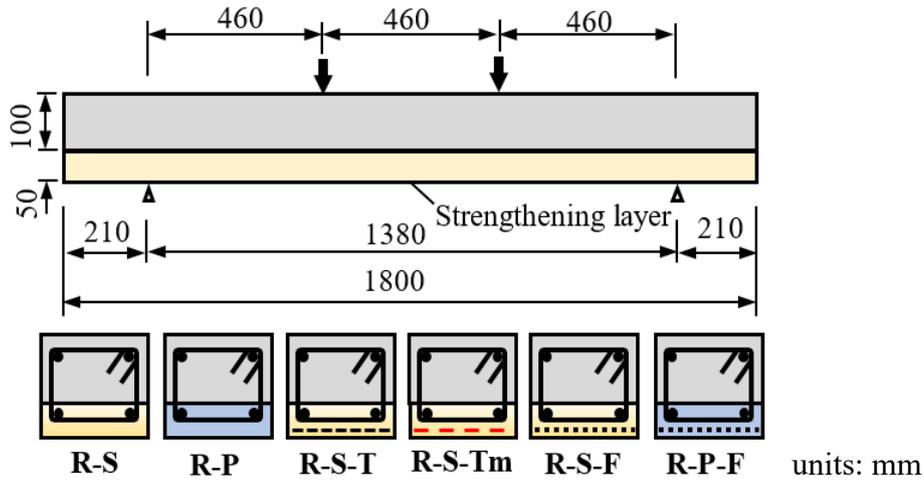
Figure 6.3 – Beams strengthened without section enlargement

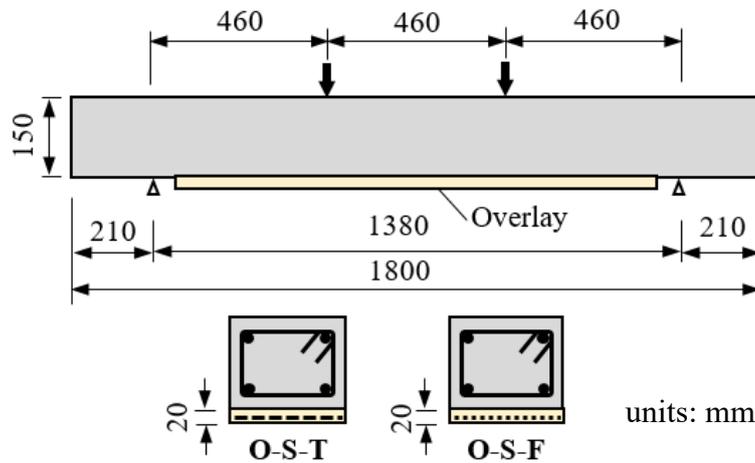
Figure 6.4 – Beams strengthened with overlay

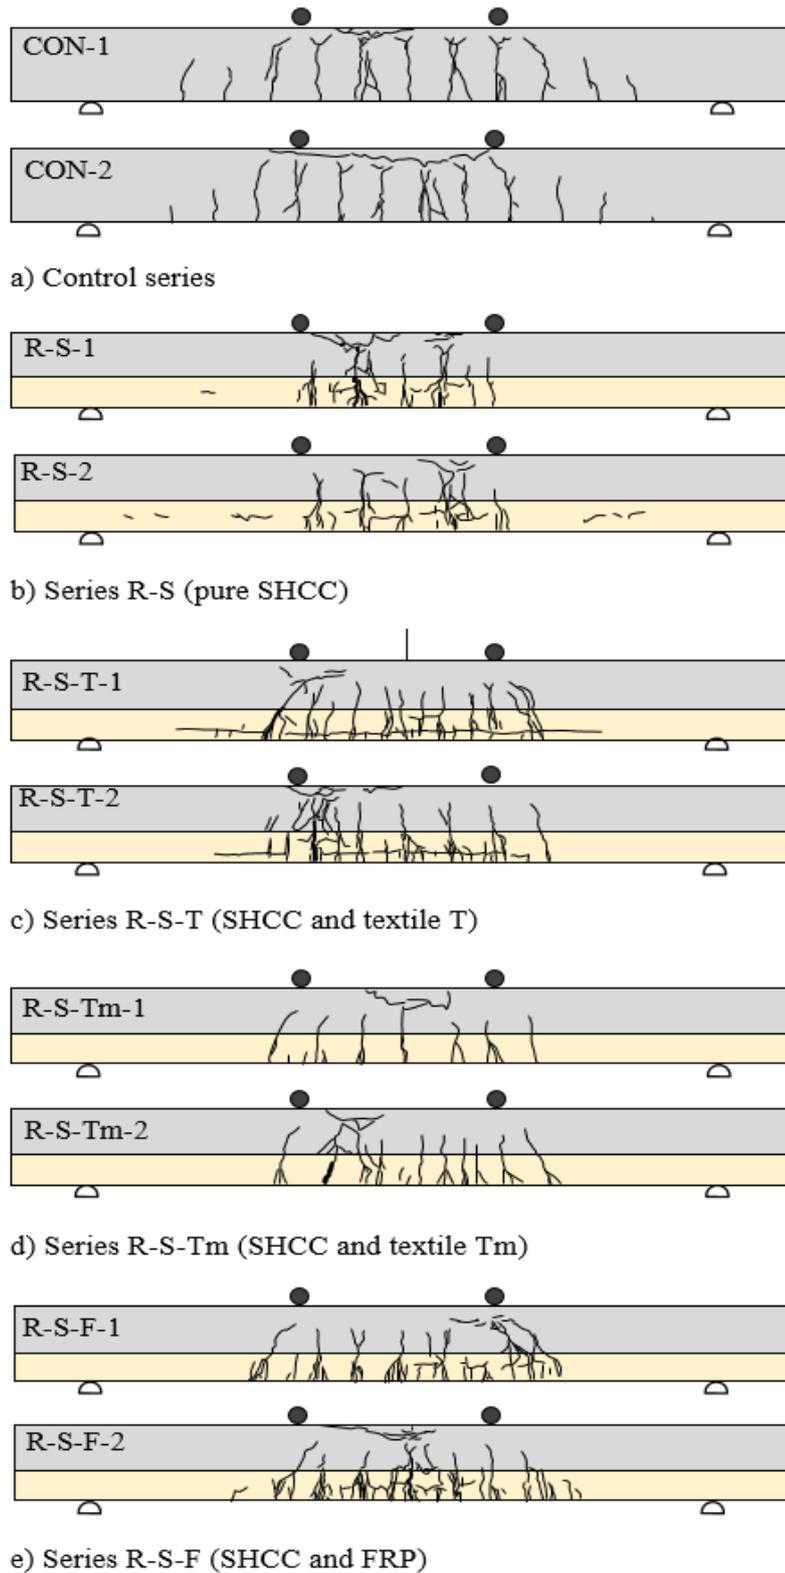
Figure 6.6 – Crack patterns of series strengthened with SHCC

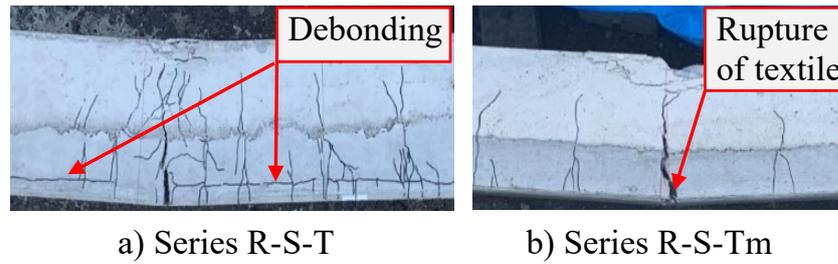
Figure 6.7– Failure mode of series R-S-T and R-S-Tm

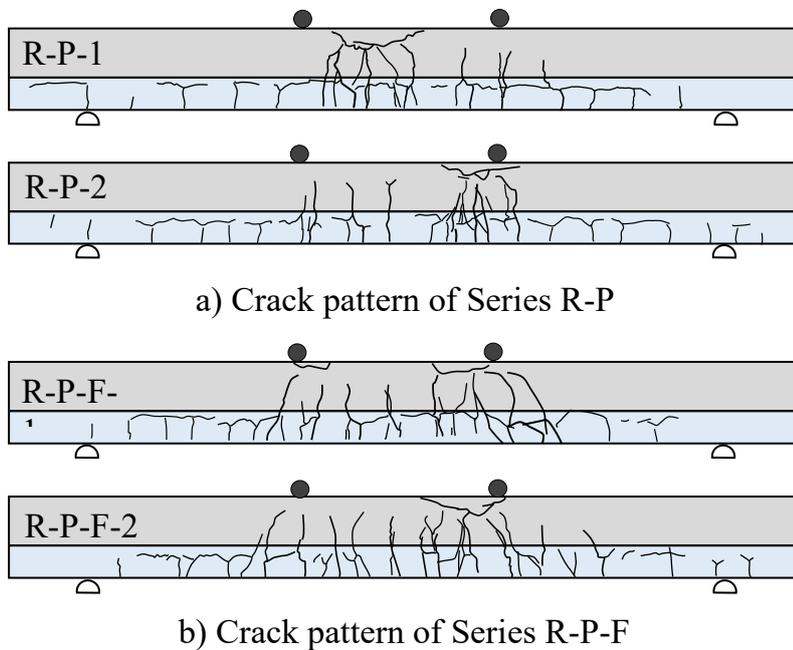
Figure 6.9 – Crack patterns of Series R-P and R-P-F

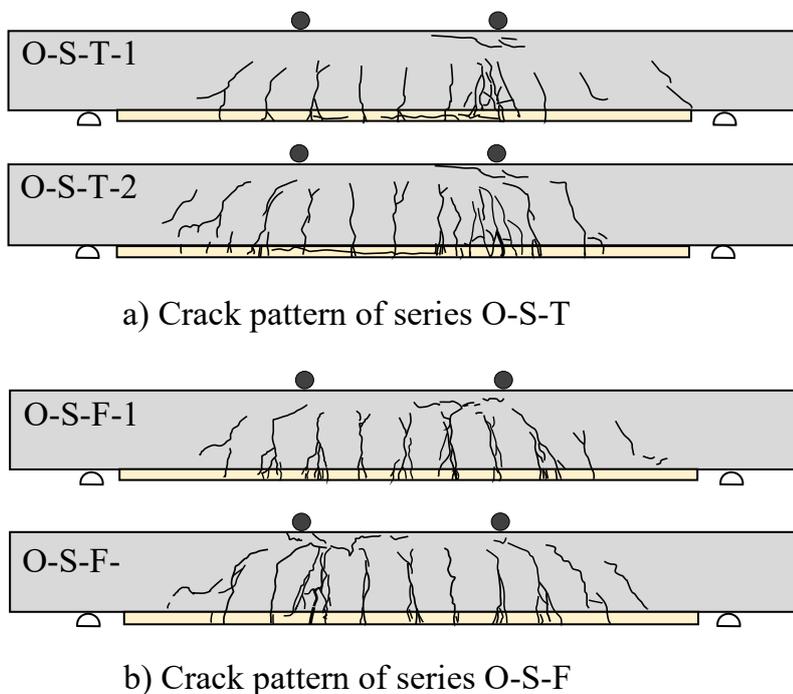
Figure 6.10 – Crack patterns of series O-S-T and O-S-F

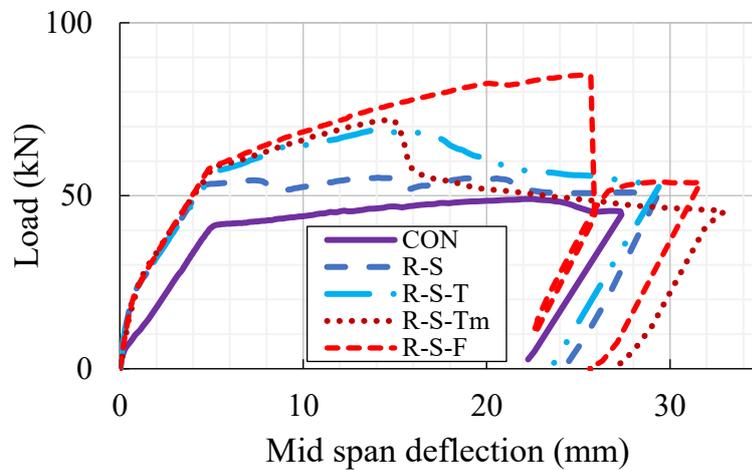
Figure 6.11 – Load-deflection of series strengthened by SHCC

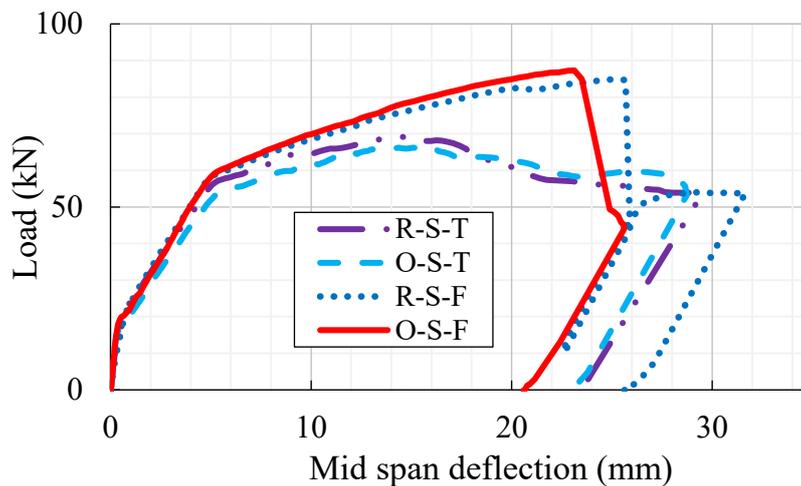
Figure 6.12 – Load-deflection of series strengthened without section enlargement versus overlay

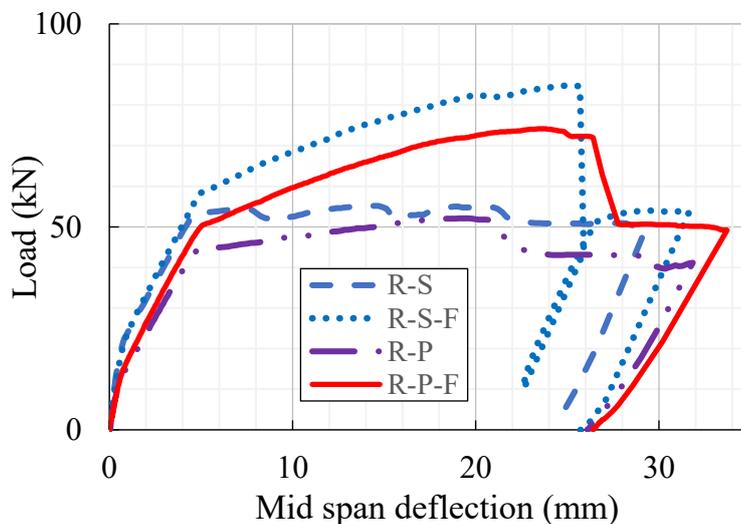
Figure 6.13 – Load-deflection of series strengthened by SHCC and PCM

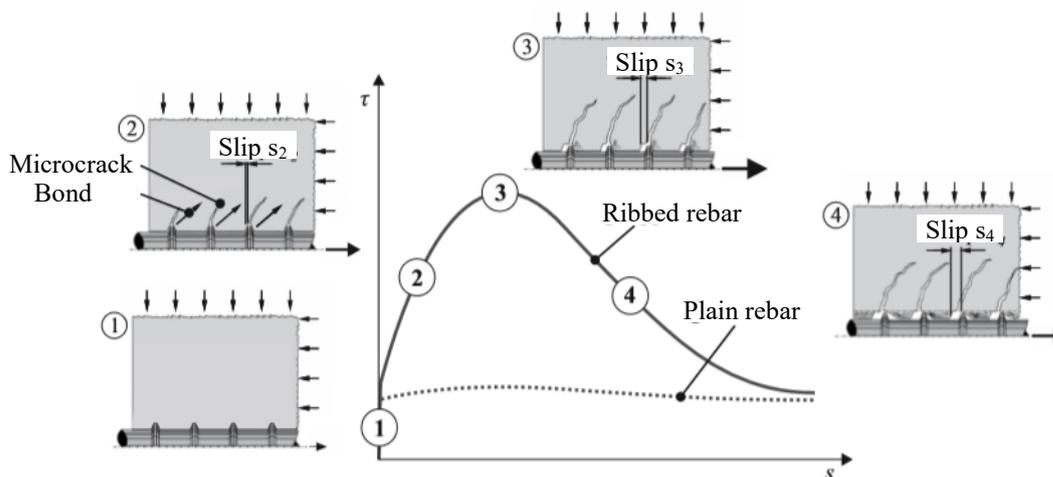
Figure 7.1 - Classification of typical bond stress-slip relationship of rebars [FIB Bulletin (2000)]

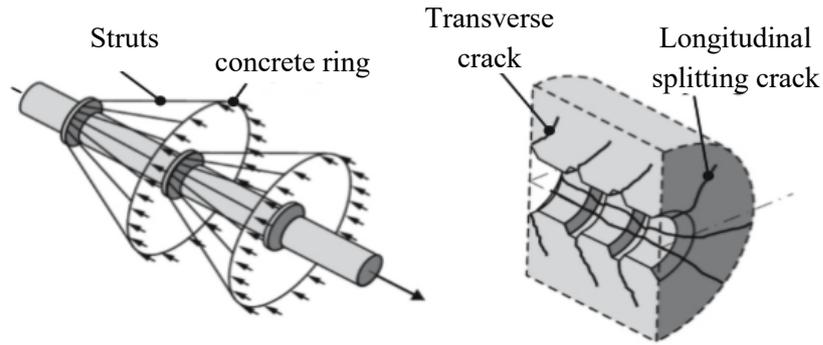
Figure 7.2 – Failure mechanisms and cracks caused by

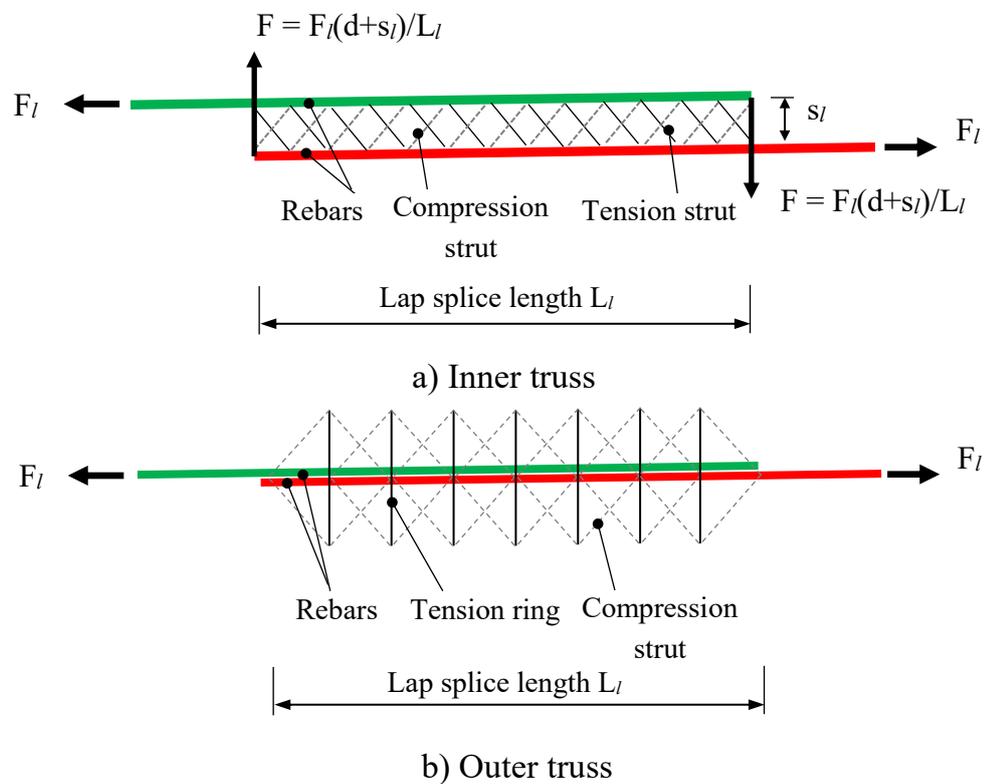
Figure 7.3 – A simplified model of the force transmission in splice zone

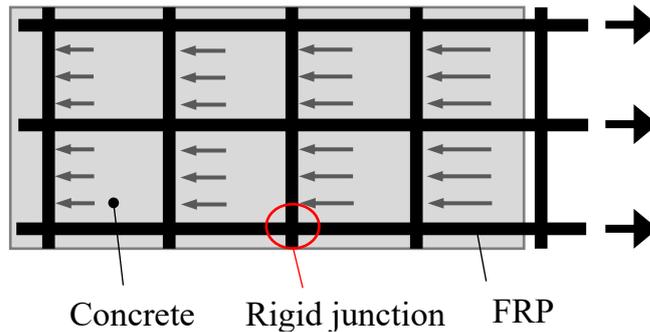
Figure 7.4 – Contribution of transverse bar

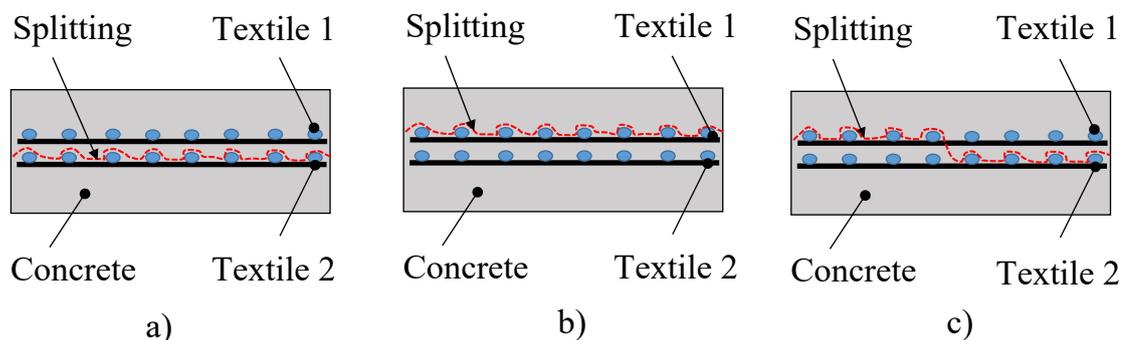
Figure 7.5 – Typical delamination failures within lap splice zone of TRC
